Maybole's Regeneration

[']MAYBOLE HERITAGE LOTTERY FUND APPLICATION STAGE 1

TOWNSCAPE & BUILDINGS

AUGUST 2016

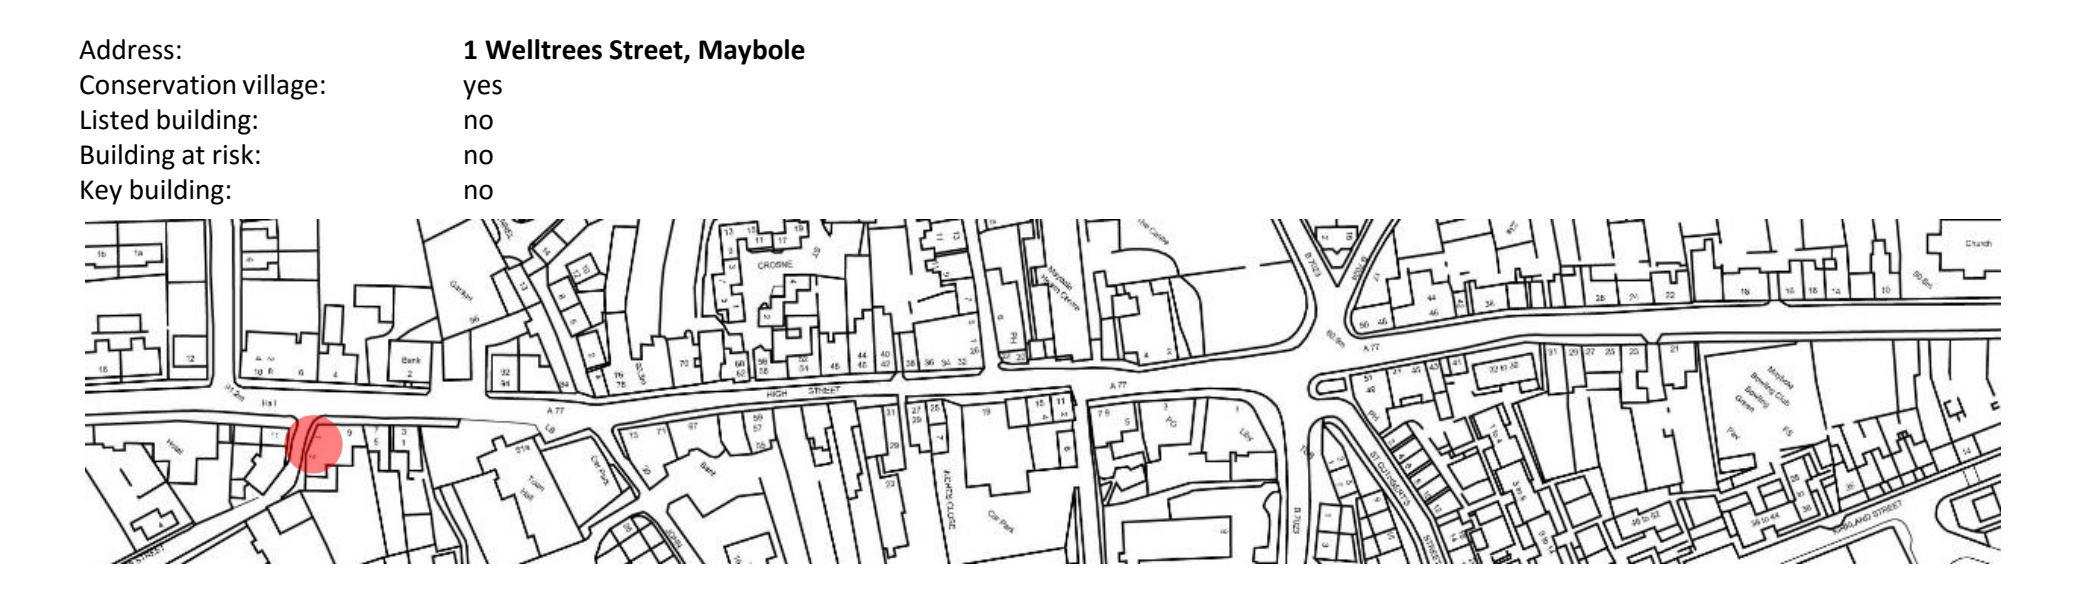
Single storey commercial corner property. The roof has been replaced recently and the building is in the process of being redeveloped (09.05.2016)

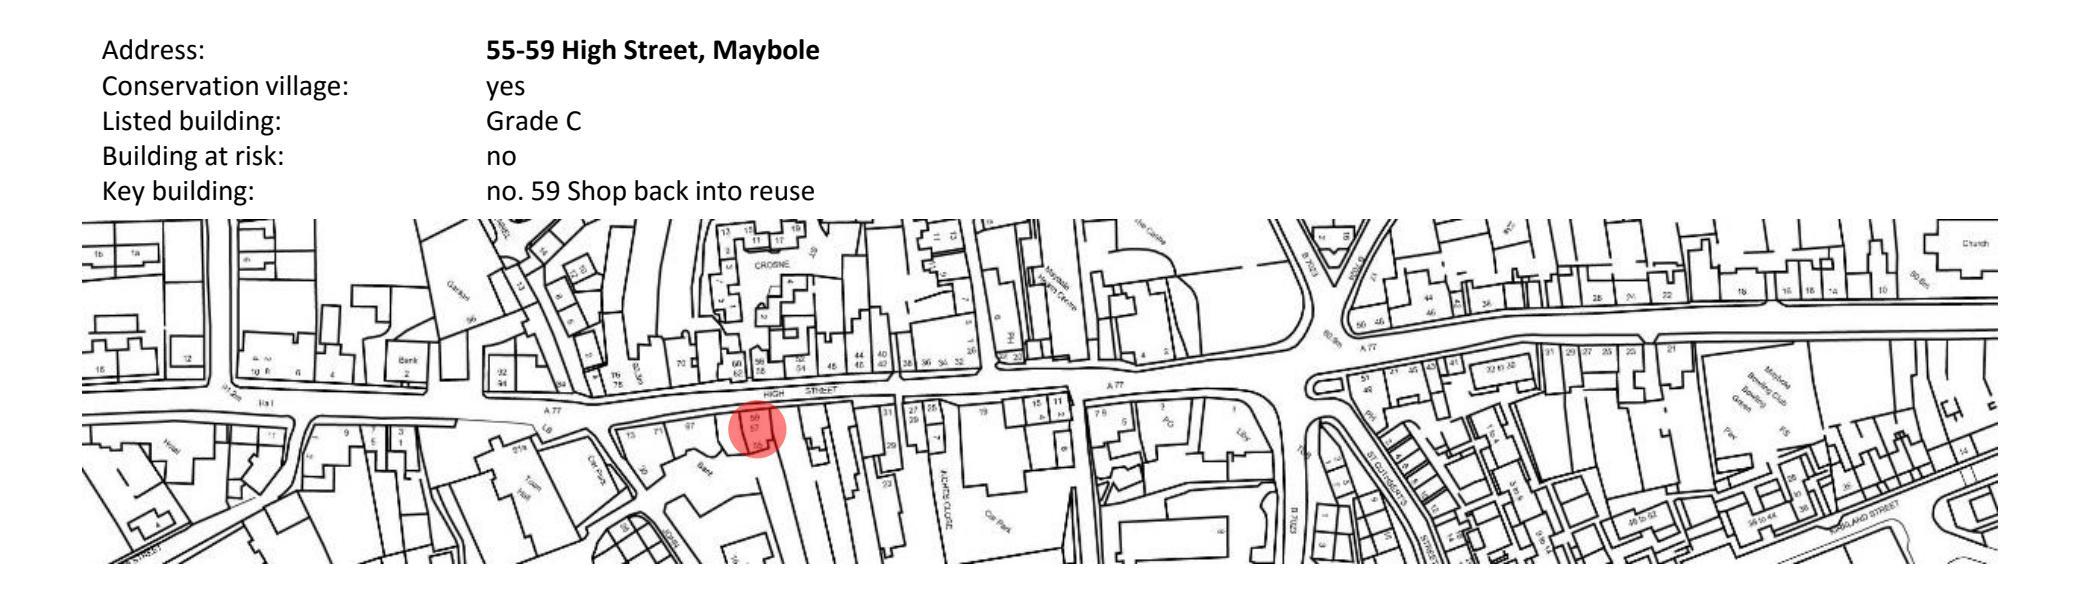
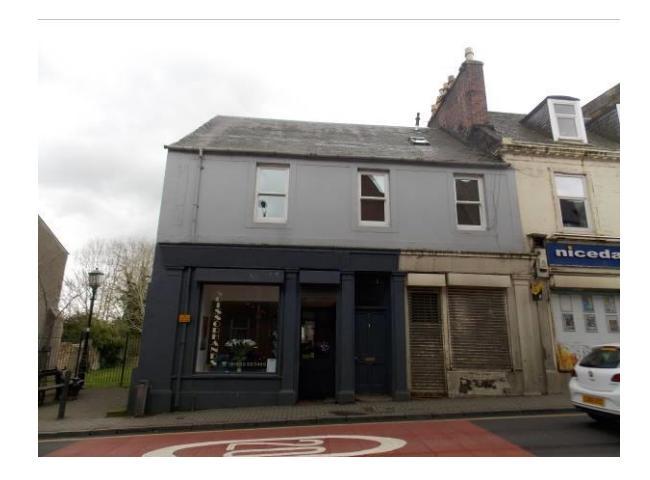
Commercial accommodation on the ground floor with one floor of residential accommodation above. No 57 ground floor shop is vacant and in poor condition

Potential works:

Paint façade Roof repairs Gutters & rainwater goods Stonework/chimney repairs Window replacement Shopfront improvements Internal shop works (no 59)

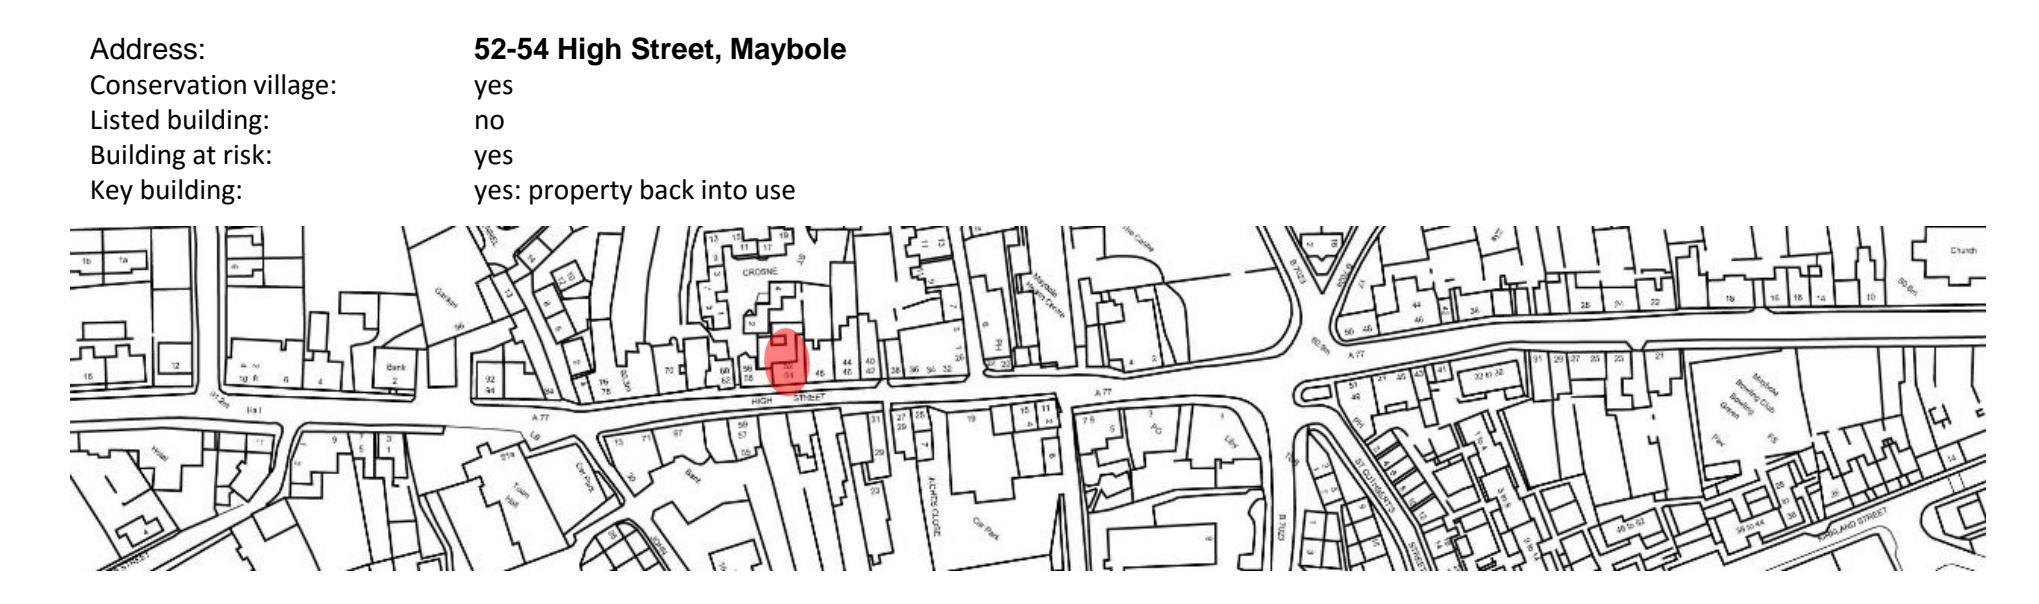
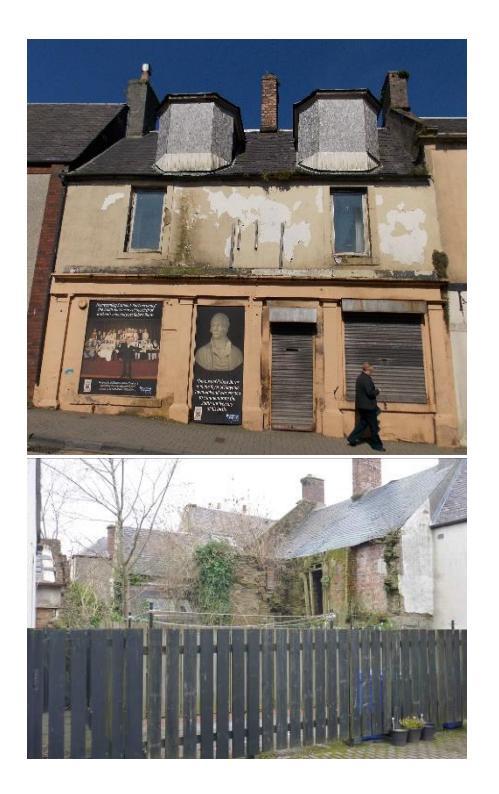
Vacant and derelict property with commercial accommodation on the ground floor with two floors of residential accommodation above. The building is in very poor condition and open to the elements at the rear. This building comprises one of the key projects. A number of planning application have been made with regards to the property.

This building comprises one of the principal projects. Please refer to section 4.4 for additional information

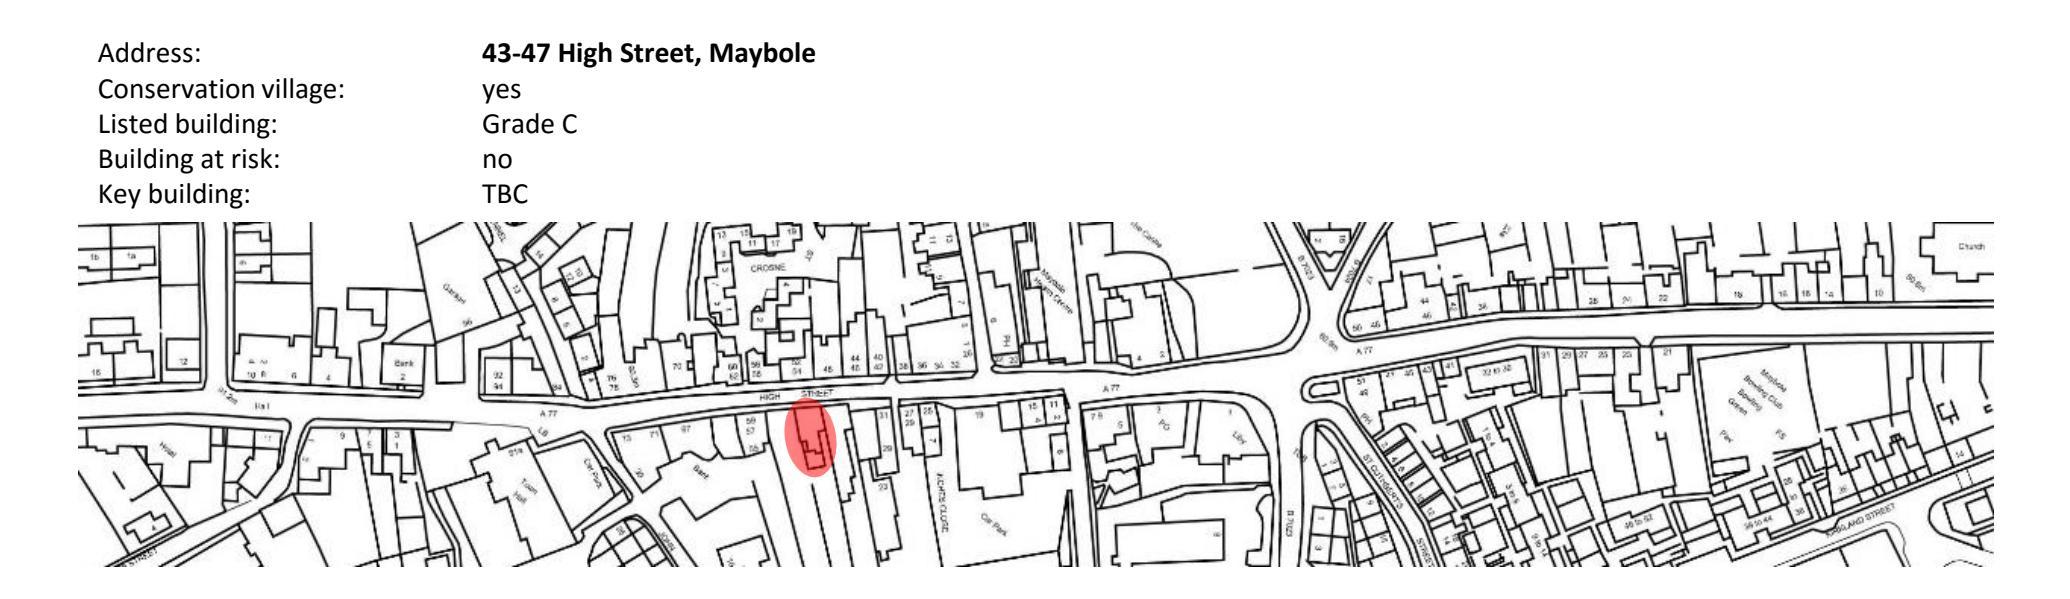
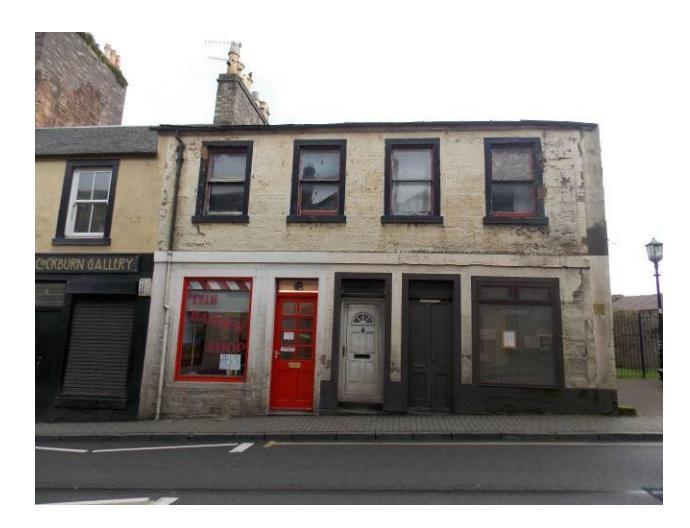
Commercial accommodation on the ground floor with one floor of residential accommodation above. No 47 ground floor shop is vacant. The façade is in poor condition

Potential works:

Paint façade Roof repairs Gutters & rainwater goods Stonework/chimney repairs Window replacement Shopfront improvements Internal shop works (no 57)

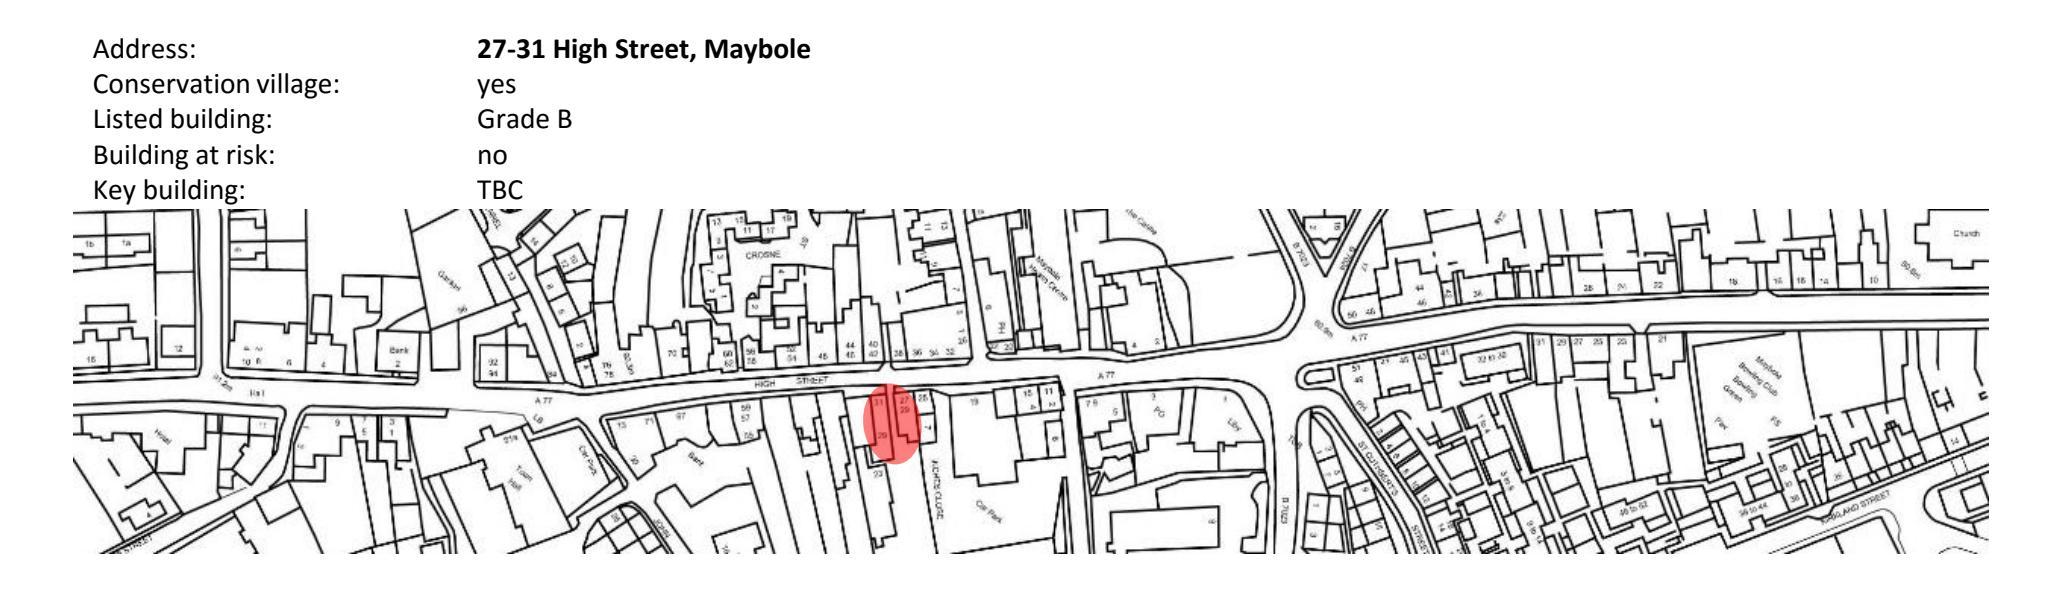
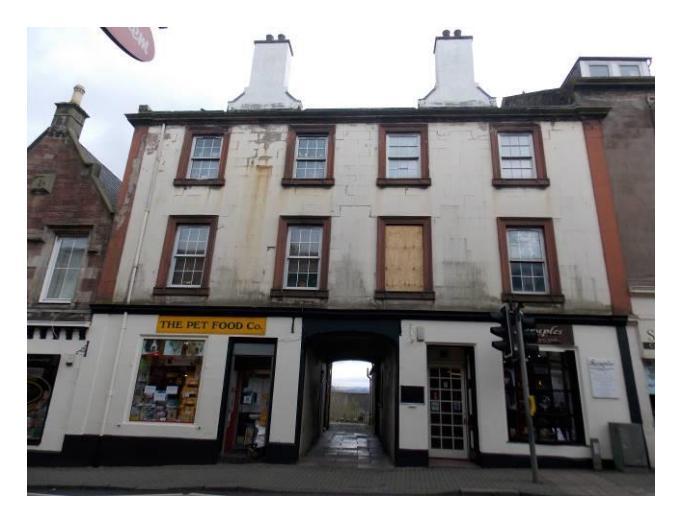
Commercial accommodation on the ground floor with two floors of residential accommodation above. The façade above the commercial properties is in poor repair

Potential works:

Paint façade Roof repairs Gutters & rainwater goods Stonework/chimney repairs Window replacement Shopfront improvements Internal shop works

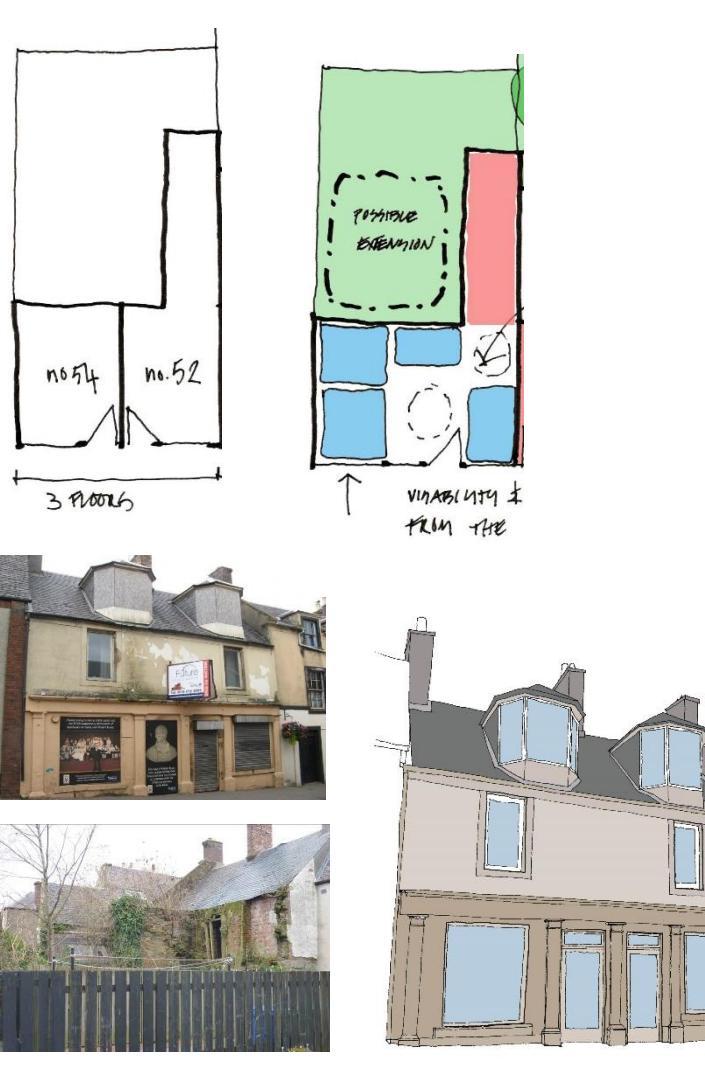
Nos. 52 & 54 (not listed, but on at risk register)

This building is derelict, open to the elements at the rear of the property and in very poor condition, and will require to be substantially rebuilt. The ground floor comprises of two small commercial properties with two floors of accommodation above. The building is fenced off to the rear and it is unsafe to enter the property to establish original layout and true condition. The upper floors were previously accessed from the garden/ rear of the property, however the rear portion of the building has been part demolished.

The proposal is to retain as much of the original building as possible, rebuild the rear façade and replace the roof throughout utilising as much reclaimed original material as possible. The internal fabric: finishes, services, surfaces, windows and structure (where required) to be stripped and replaced throughout and provide new vertical circulation stair. New electrics, heating, plumbing and services throughout to make the building energy efficient and an attractive proposition for both commercial and residential use. Consideration should be given to combining the ground floor shops to create a larger premises whilst retaining the more traditional shop front façade, with the ability to revert them back to two smaller premises in the future. Whilst planning permission has been granted to extend the property to the rear, this is not included within the proposals.

- Rebuild existing rear façade and stabilise front façade and chimneys where required
- Planning permission exists for an extension to the rear of the property
- New slate roof, copes, leadwork gutters & rainwater goods utilising existing retained materials where possible
- New internal floor structure, stairs, insulation, finishes & fixtures throughout
- New services throughout: plumbing, heating electrics
- New windows and dormer windows throughout
- · Replacement shop front windows and external doors & security grilles
- New shop front signage
- Paint front façade and shop front
