Maybole's Regeneration

[']MAYBOLE HERITAGE LOTTERY FUND APPLICATION STAGE 1

TOWNSCAPE & BUILDINGS

AUGUST 2016

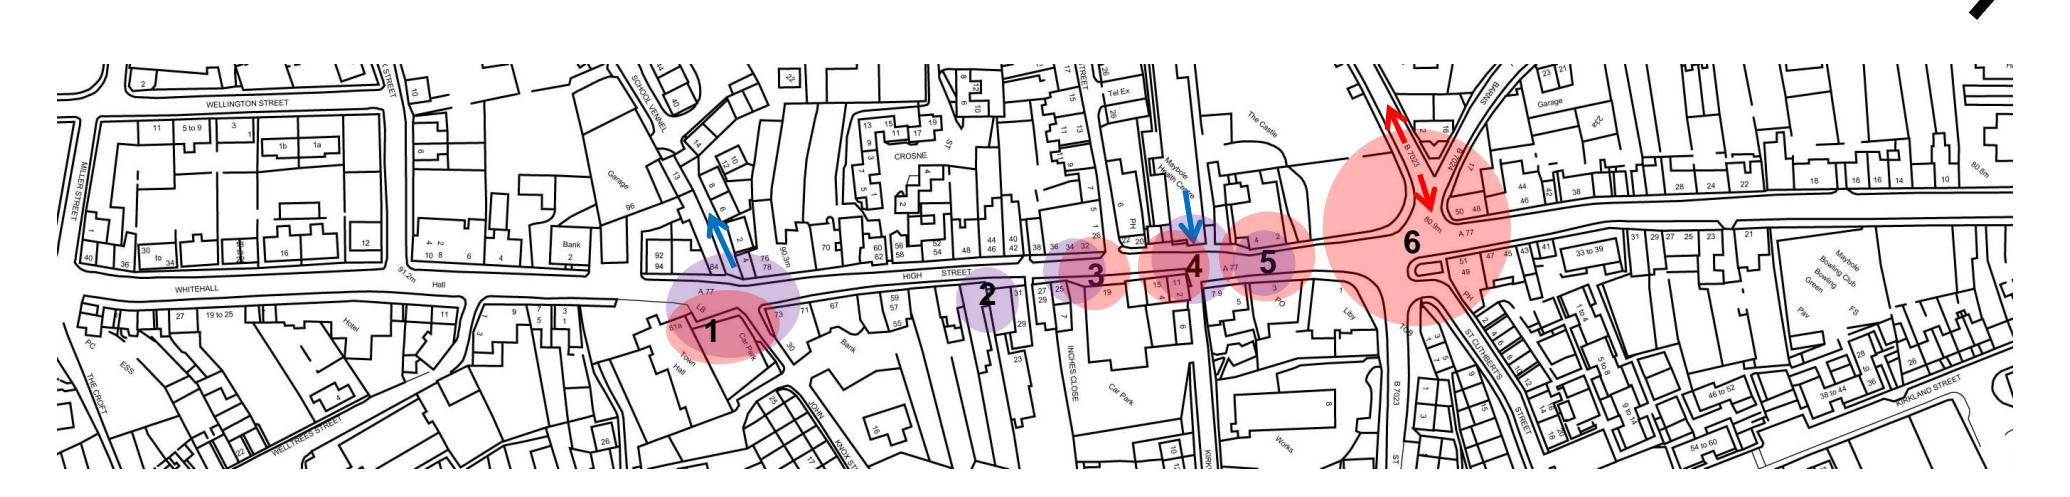
HIGH STREET: EXISTING PAVEMENT & ACCESS ISSUES

The existing pavements are in general narrow throughout the town centre, however in addition to this there are a number of locations where the pavement narrows substantially creating access issues for pedestrian

Pedestrian issue: main footpath link to train station, crosses busy main street reduced footpath area outside the main door to the town hall Vehicular issue: drop off area outside town hall consistently used for parking access to car parks via side road

Building issue: there is very little space around the building to the north west and side entrance

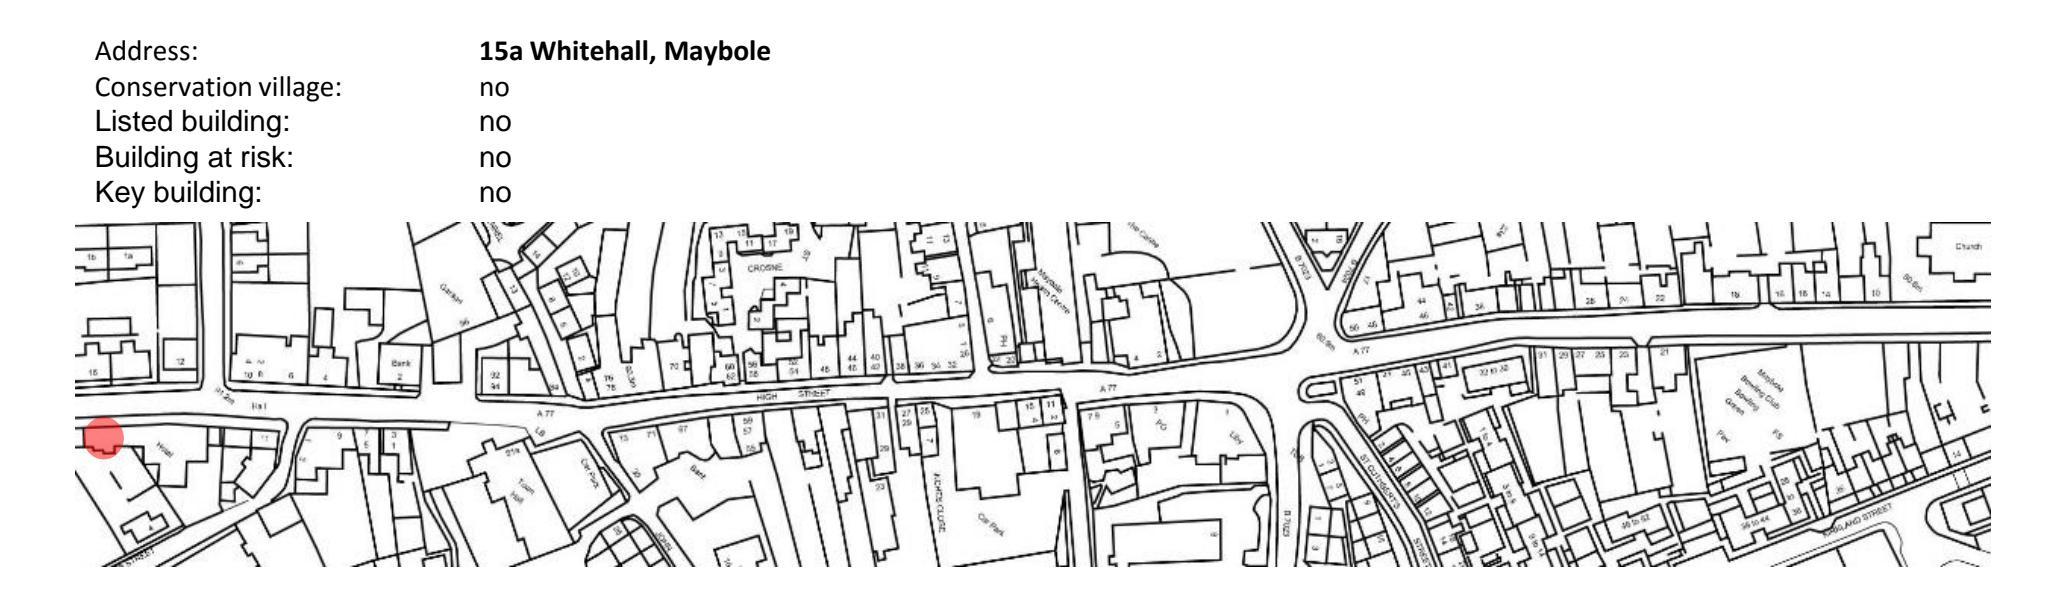
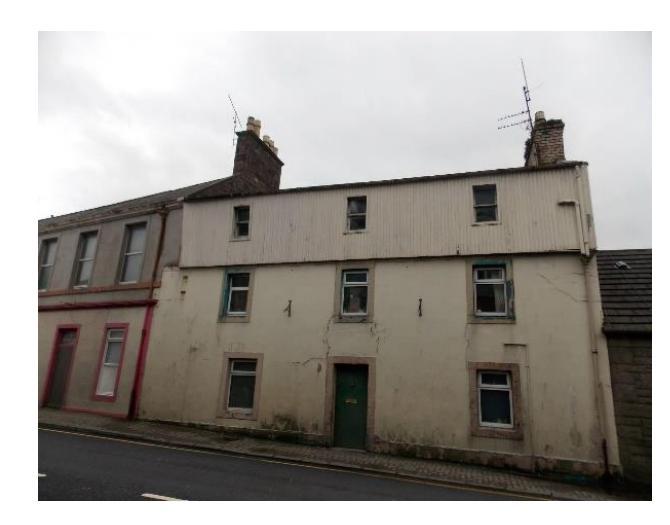
Residential property, the second floor is a timber addition with no accommodation behind it, the original roof line remains and is obscured behind the false timber façade. The building used to be connected to the adjacent property at no 15; which formed part of a hotel complex of buildings.

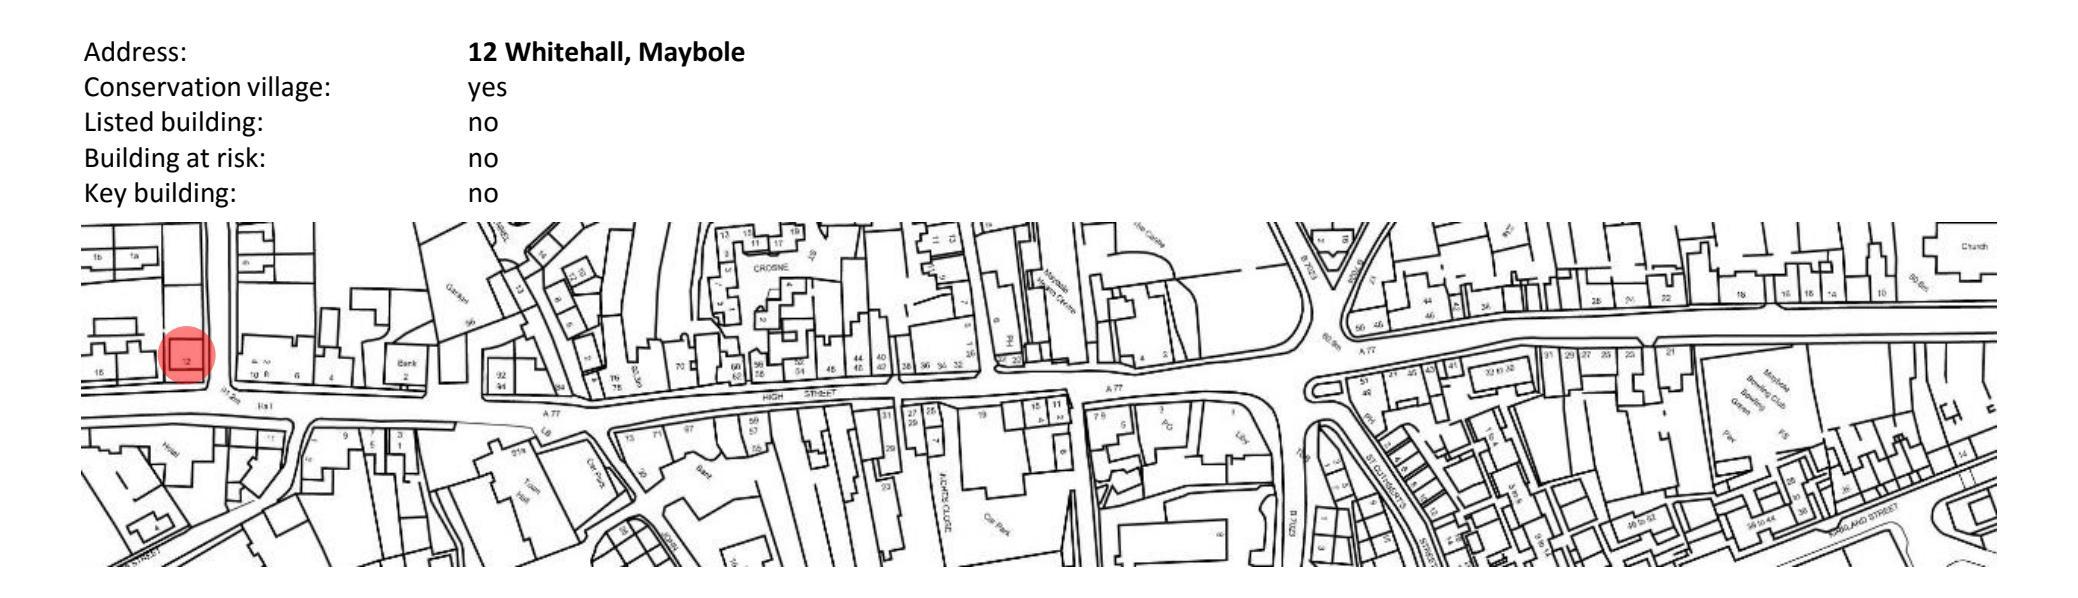
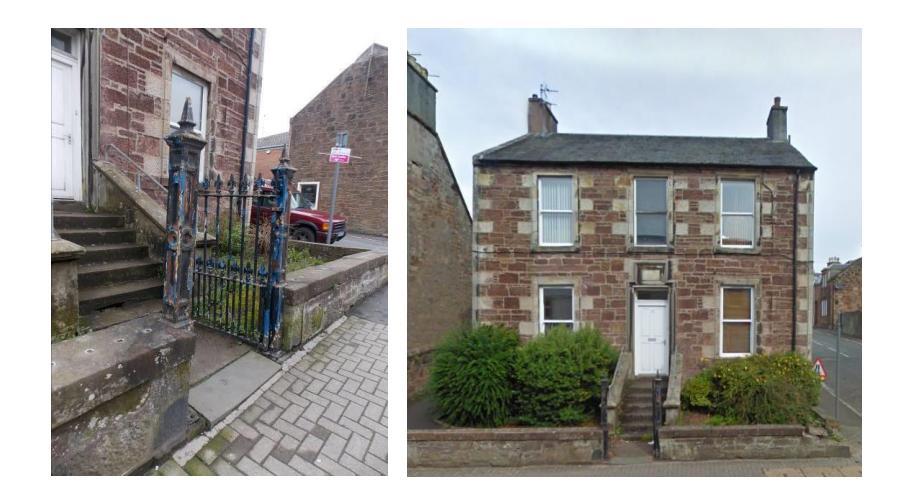
Private residential property, the external railings have been removed, however the existing gate and gate posts remain

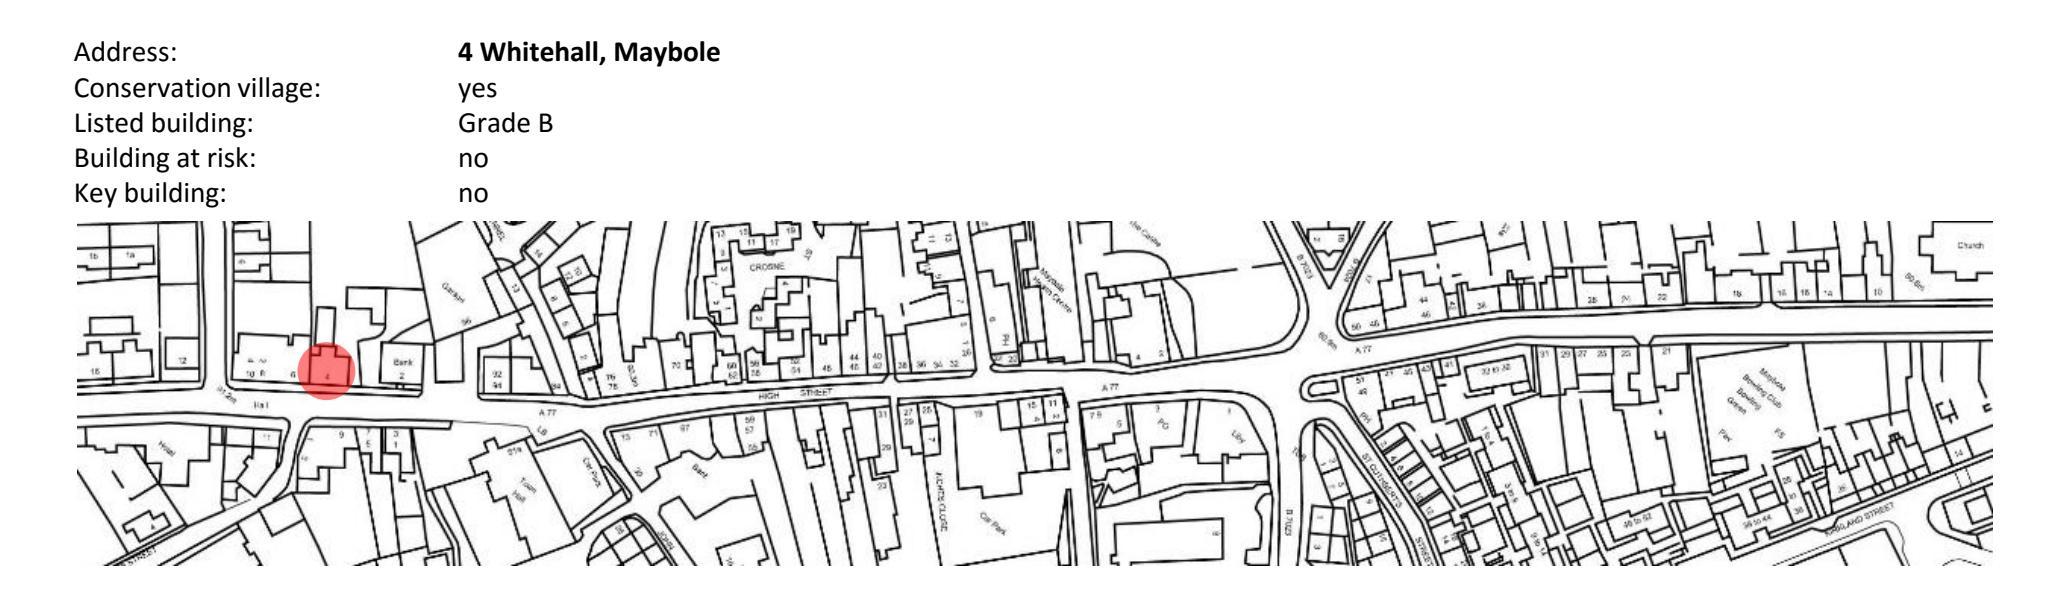
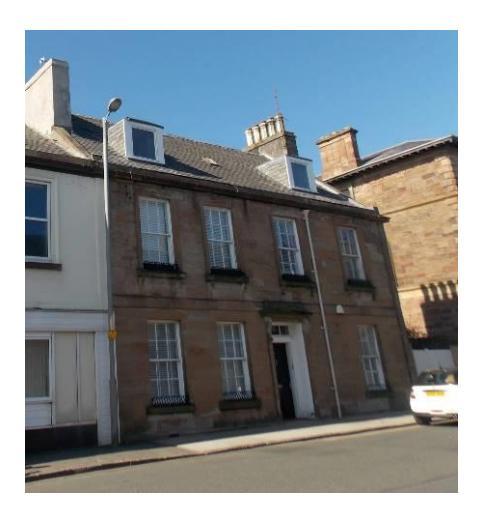
Previously owned by the adjacent Speakers, this building is now a private residential property

Paint façade Roof repairs Gutters & rainwater goods Stonework/chimney repairs Window replacement Shopfront improvements Internal shop works

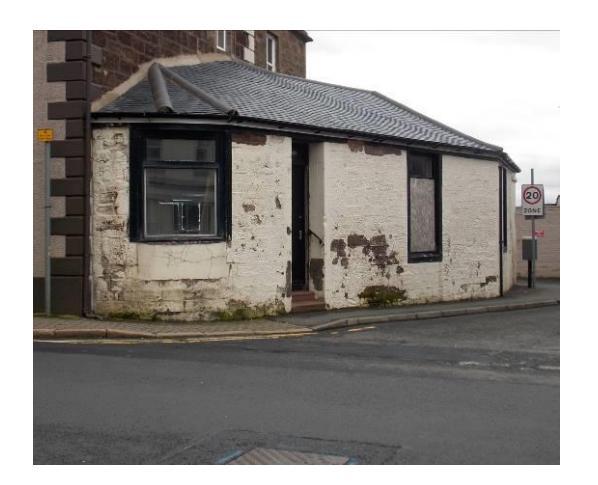
Single storey commercial corner property. The roof has been replaced recently and the building is in the process of being redeveloped (09.05.2016)

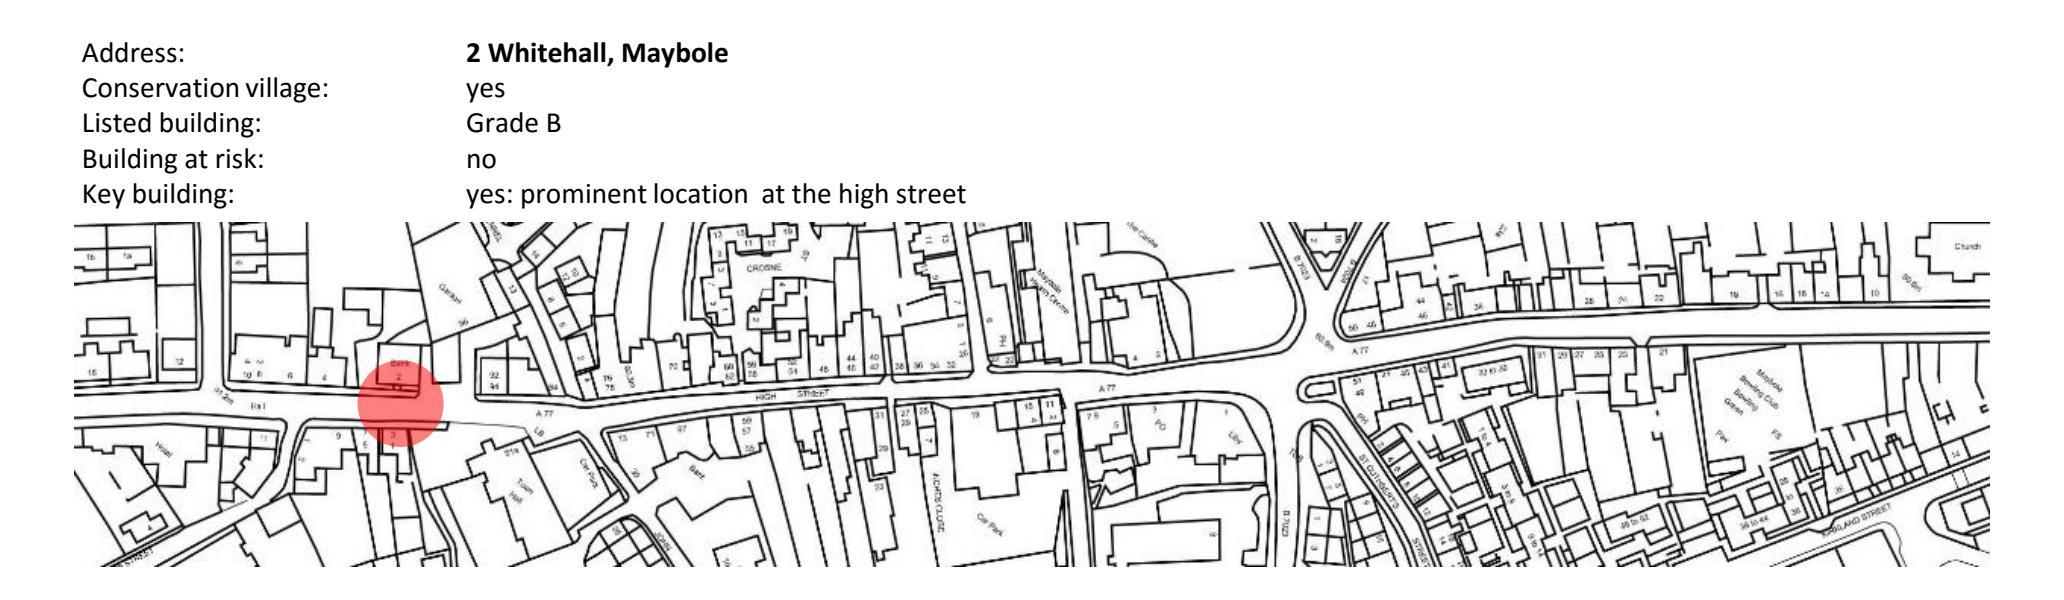
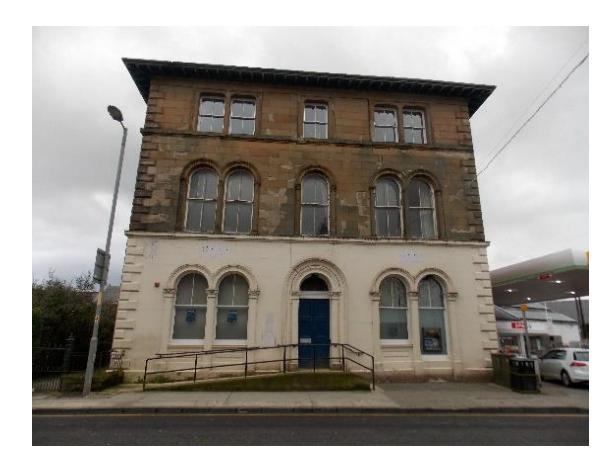
The ground floor was until recently used by the Royal Bank Of Scotland and is currently vacant. The first and second floors contain private residential properties. There is a limited garden to the rear with ramped access to the front door

Paint façade Roof repairs Gutters & rainwater goods Stonework/chimney repairs Window replacement Shopfront improvements Internal shop works

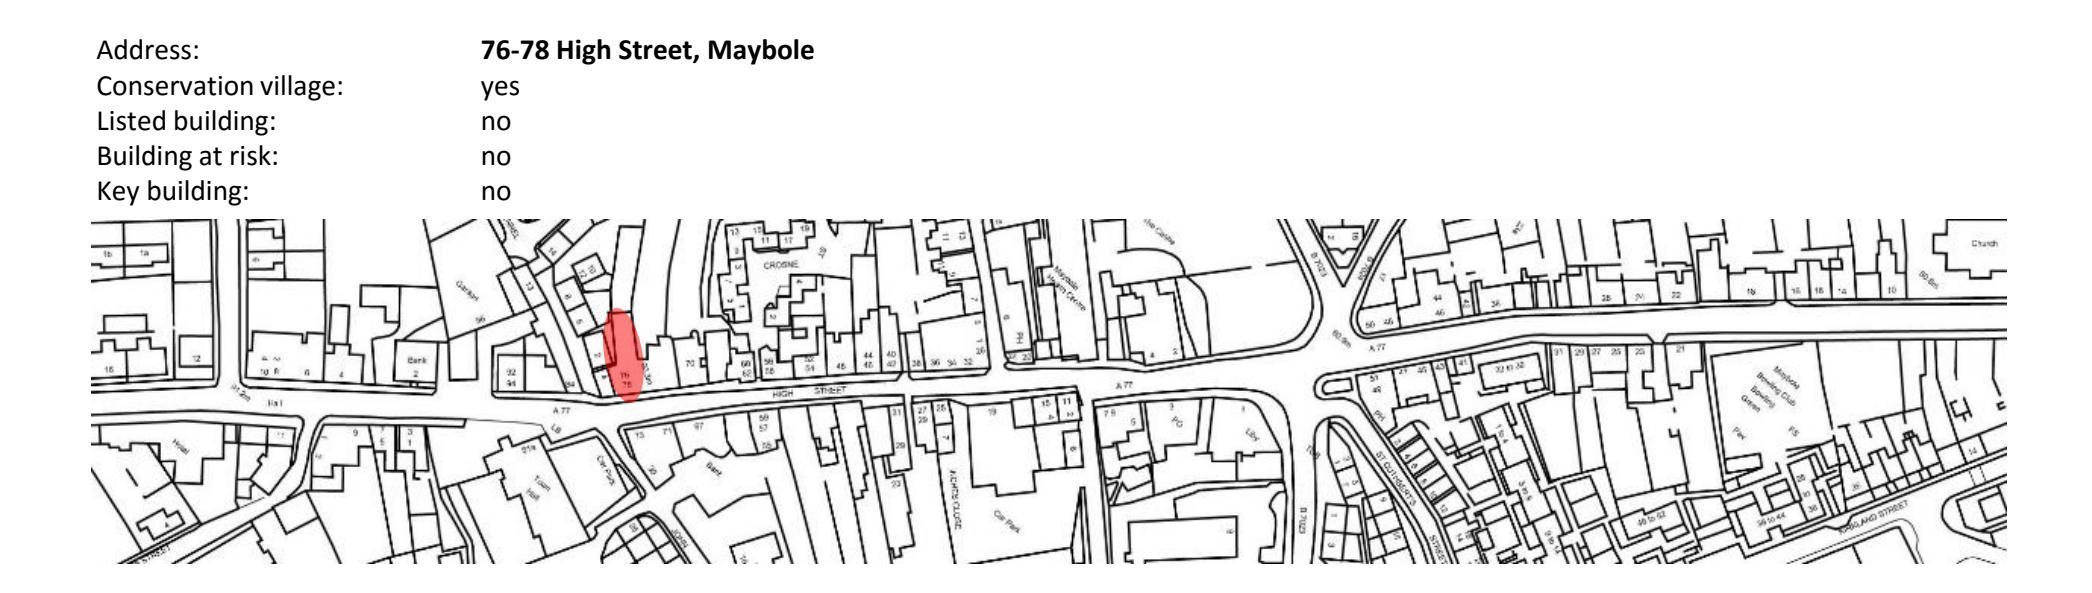
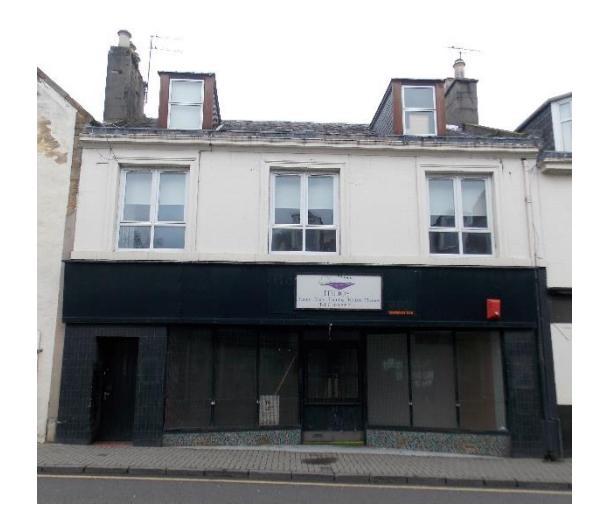
Vacant commercial accommodation on the ground floor with two floors of residential accommodation above. The commercial unit has been vacated recently and is in good repair with some traditional features retained.

Paint façade
Roof repairs
Gutters & rainwater goods
Stonework/chimney repairs
Window replacement
Shopfront improvements
Internal shop works

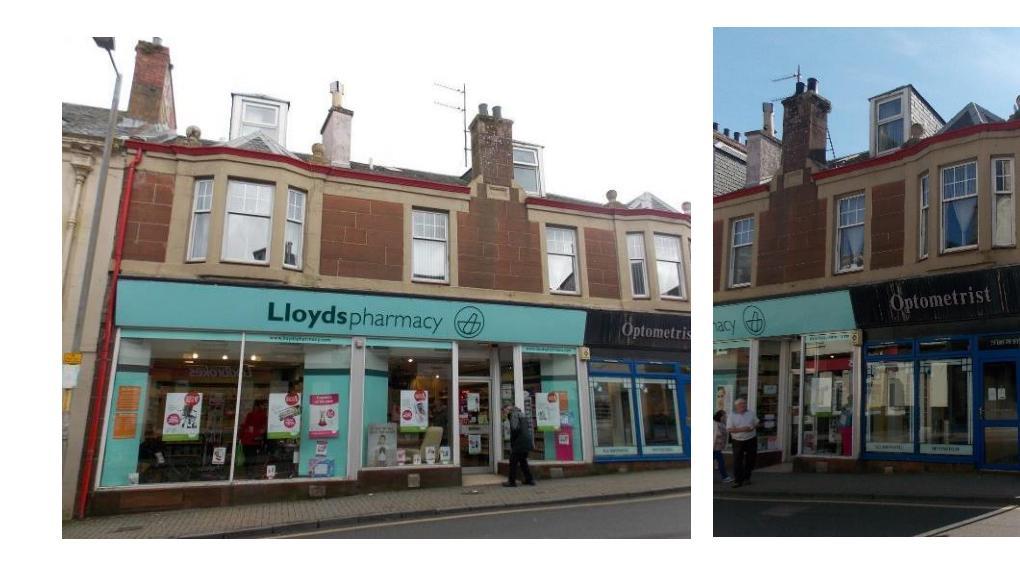
Commercial accommodation on the ground floor with two floors of residential accommodation above. Bothe commercial properties are in use

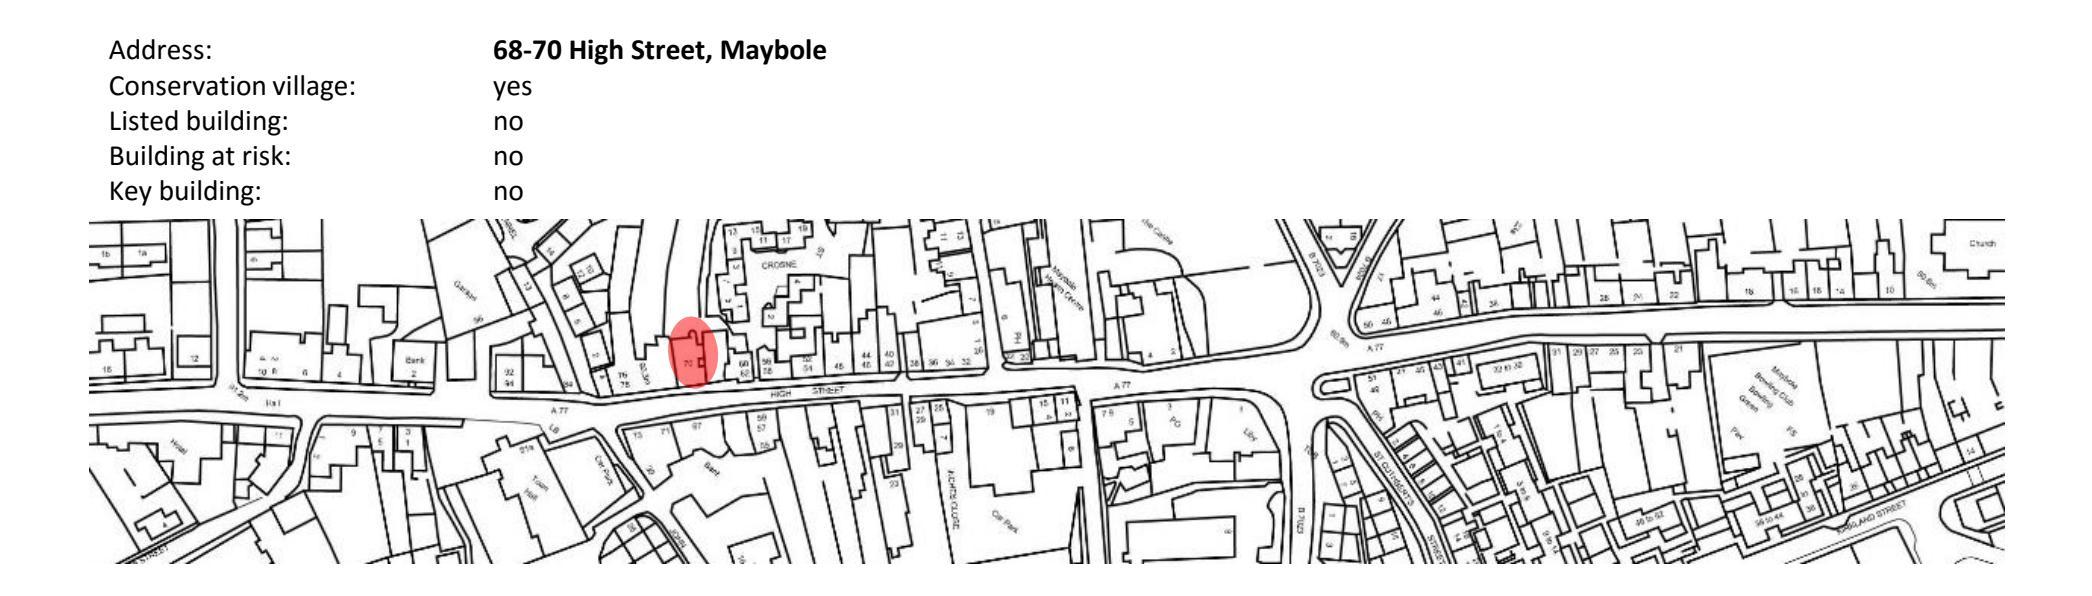
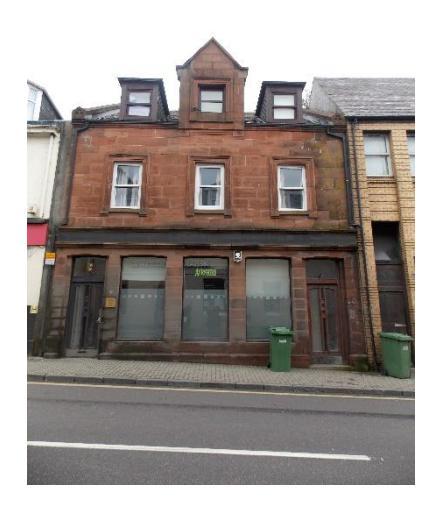
Commercial accommodation on the ground floor housing used by the local council with two floors of residential accommodation above.

Potential works:
Paint façade
Roof repairs
Gutters & rainwater goods
Stonework/chimney repairs
Window replacement
Shopfront improvements
Internal shop works

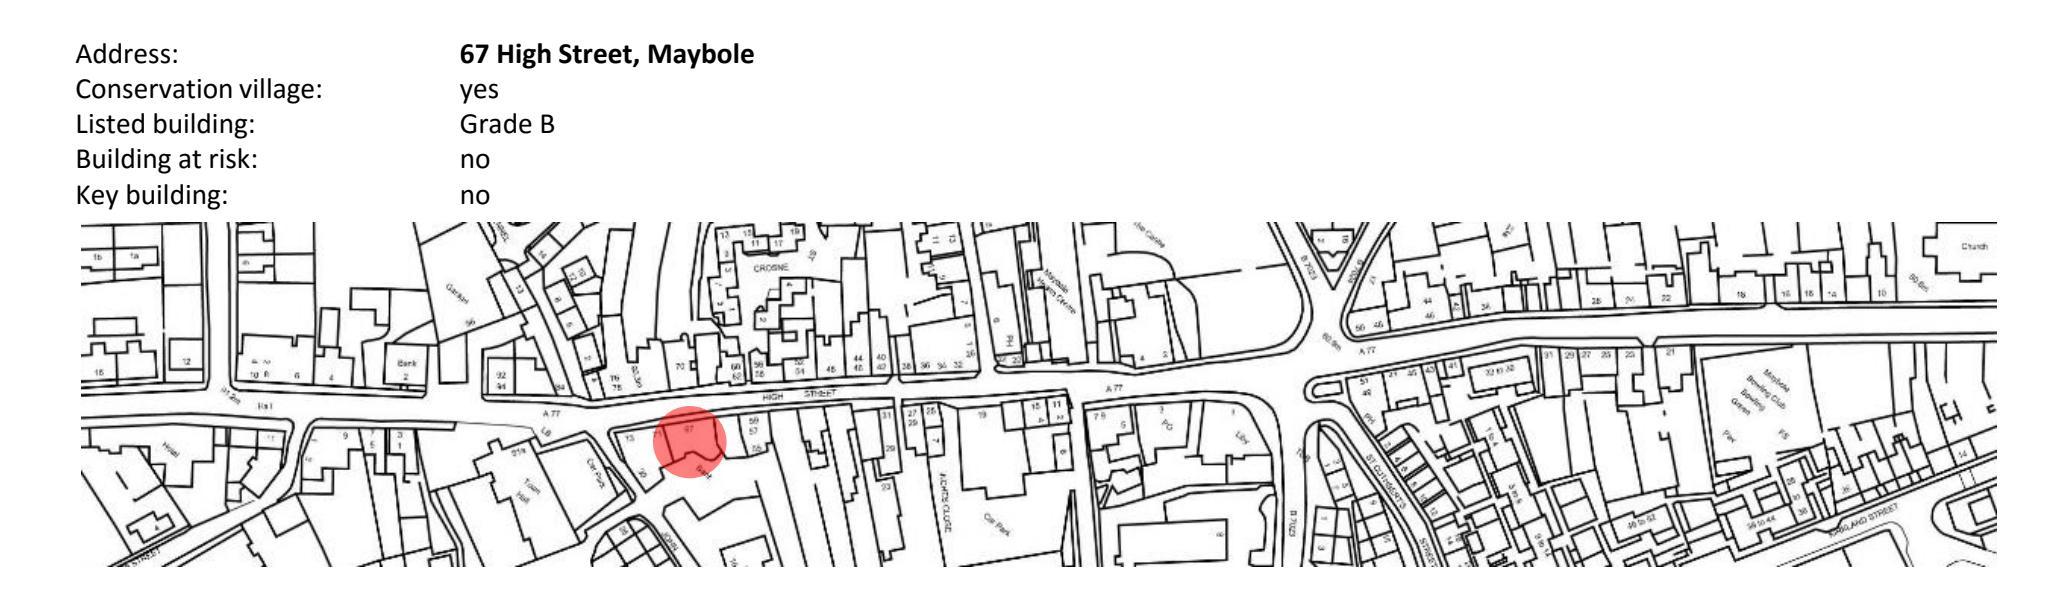
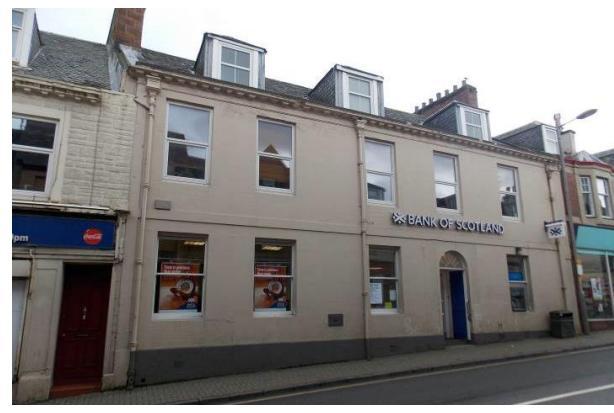
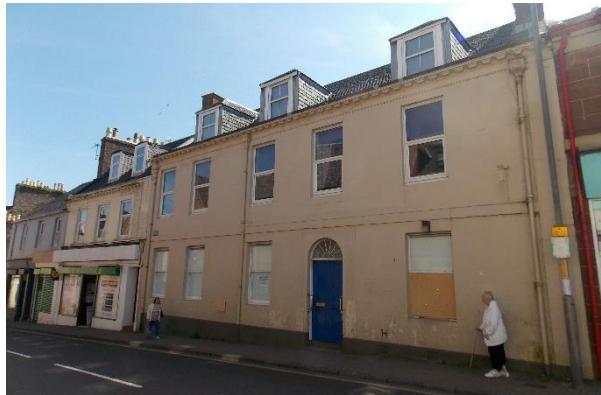
The ground floor was previously a bank property which has only recently been vacated, with 2 floors of residential accommodation above. The property is in good condition.

Paint façade Roof repairs Gutters & rainwater goods Stonework/chimney repairs Window replacement Shopfront improvements Internal shop works

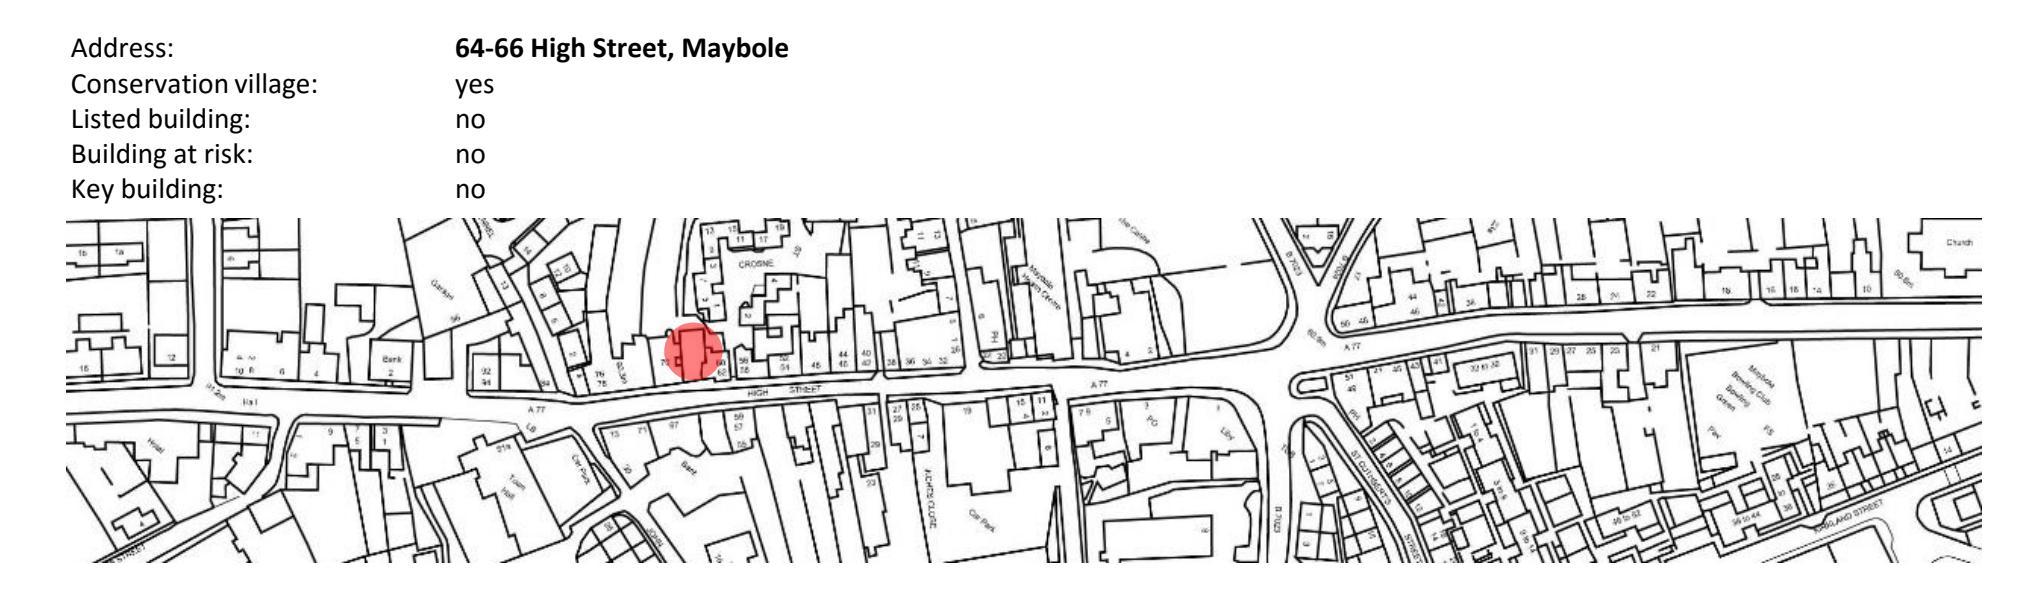
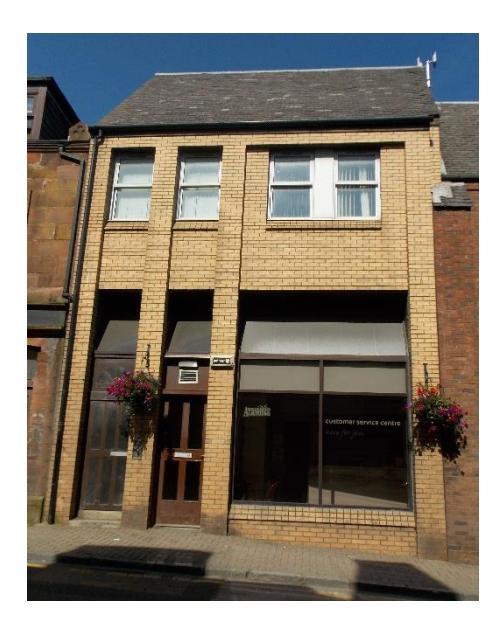
Ground floor commercial property with residential above. The building is of modern brick construction

Paint façade		
Roof repairs		
Gutters & rainwater goods		
Stonework/chimney repairs		
Window replacement		
Shopfront improvements		
Internal shop works

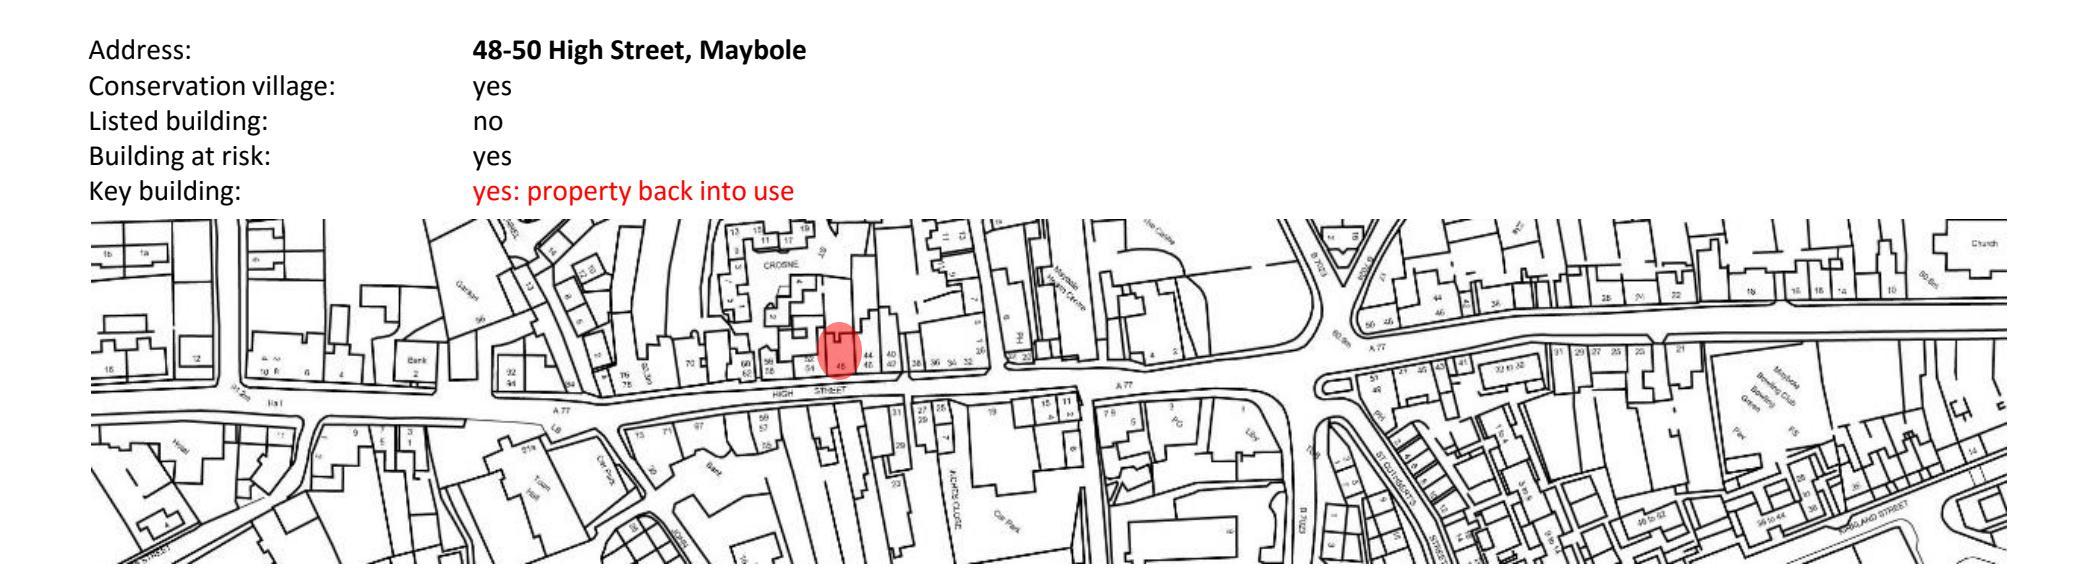
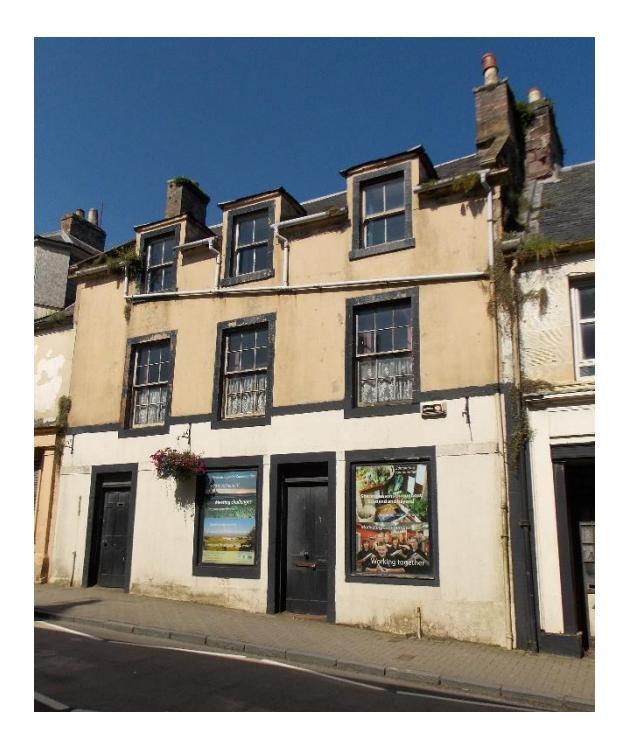
Vacant property with commercial accommodation on the ground floor with two floors of residential accommodation above. This building comprises one of the key projects

This building comprises one of the principal projects. Please refer to section **4.4** for additional information

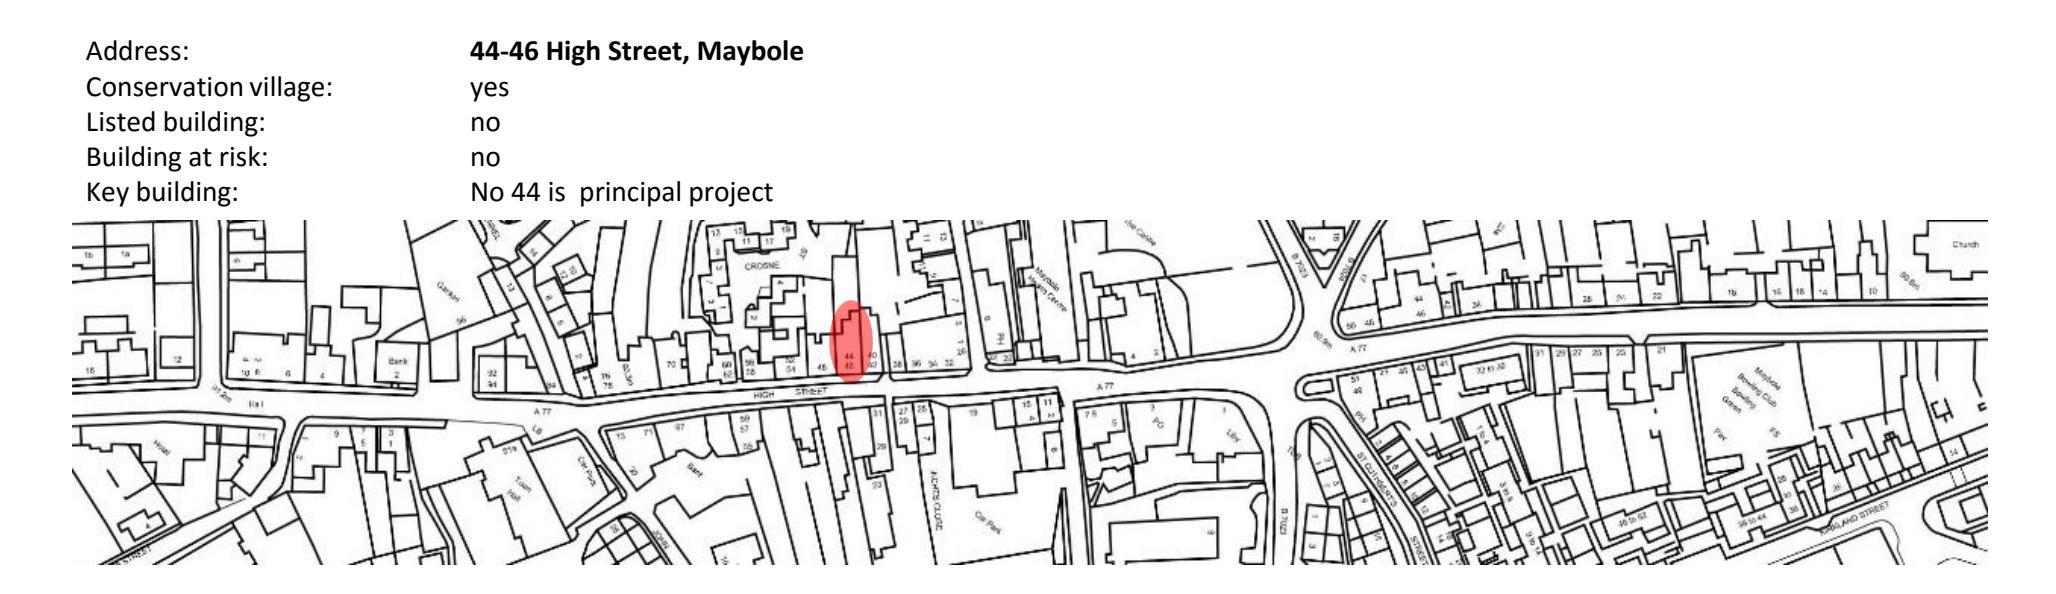
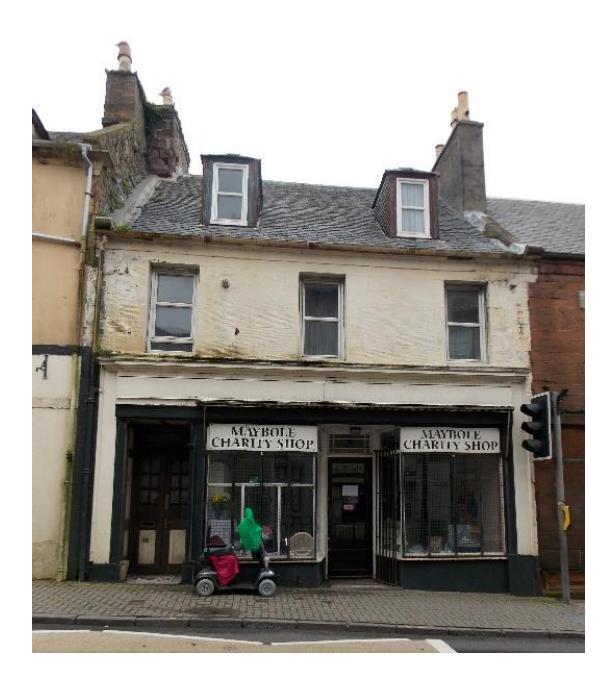
Commercial accommodation on the ground floor with two floors of residential accommodation above. The Community run charity is one of the principal projects: please refer to individual proposal document for additional information

This ground floor shop comprises one of the principal projects. Please refer to the proposal for additional information

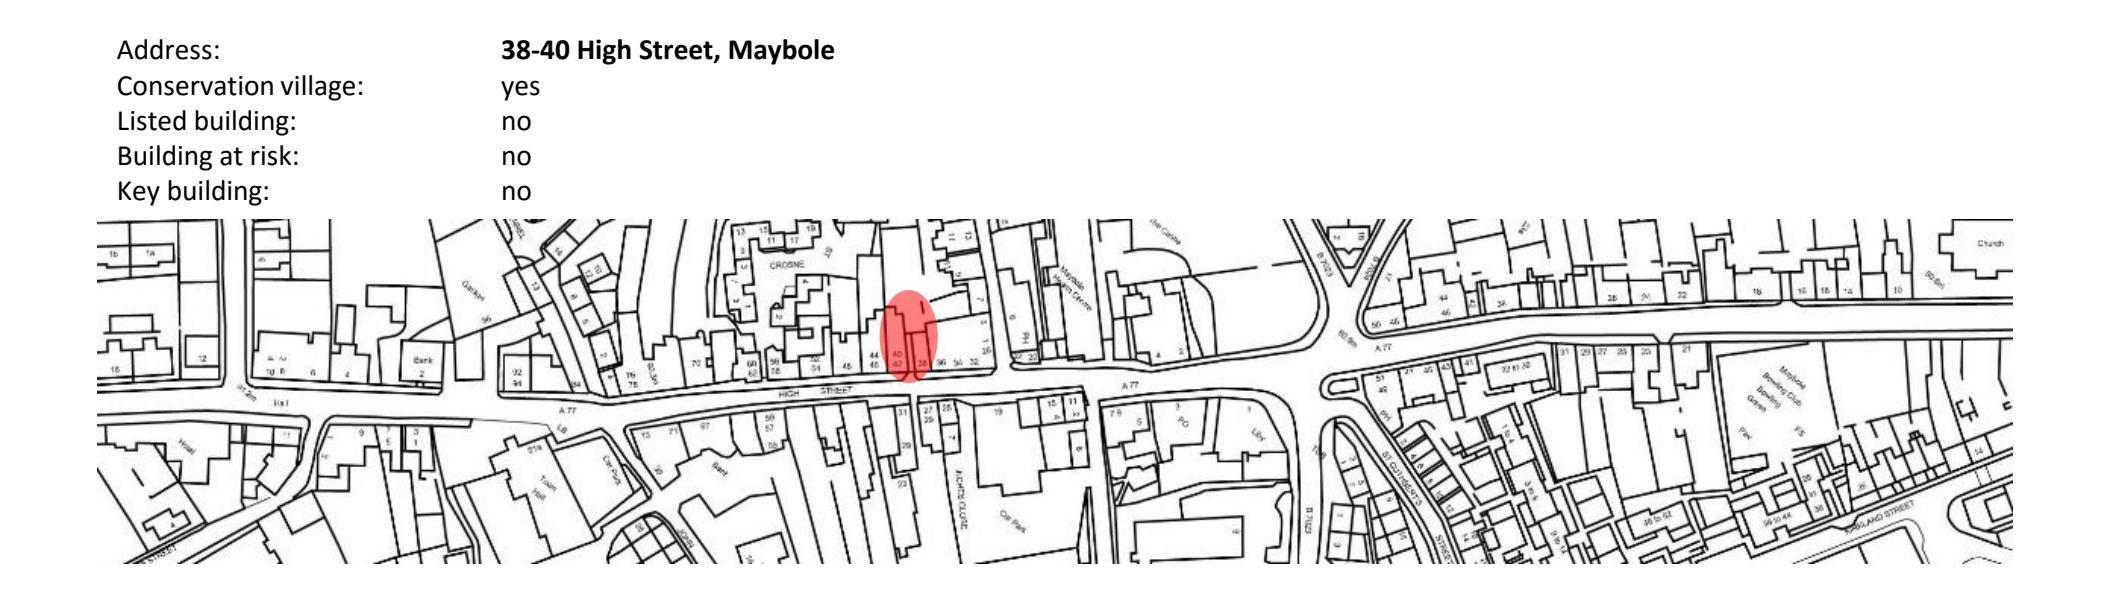
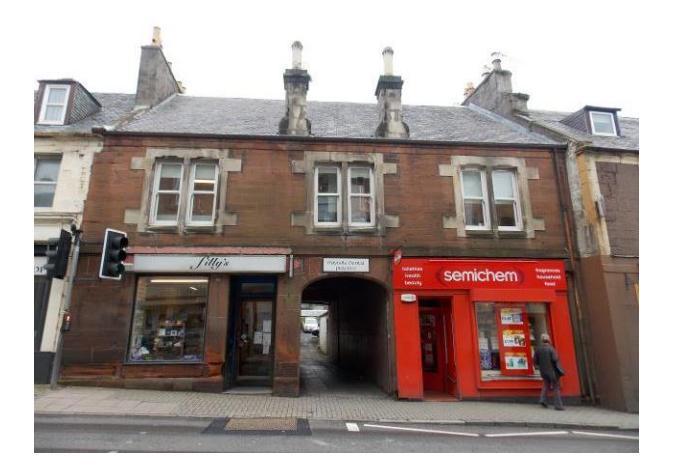
Commercial accommodation on the ground floor with residential accommodation above. Property in good repair

Paint façade Roof repairs Gutters & rainwater goods Stonework/chimney repairs Window replacement Shopfront improvements Internal shop works

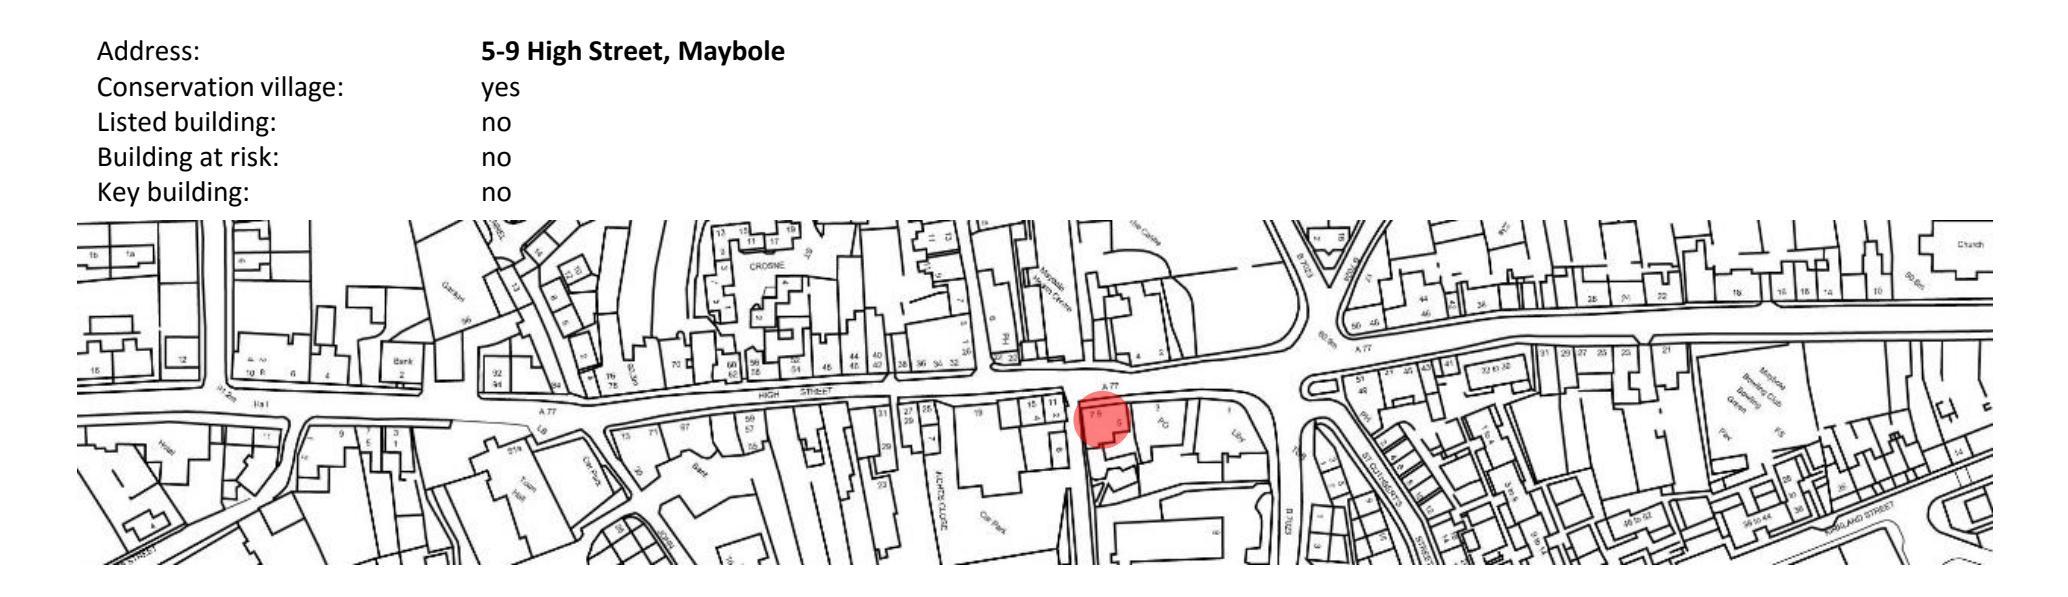
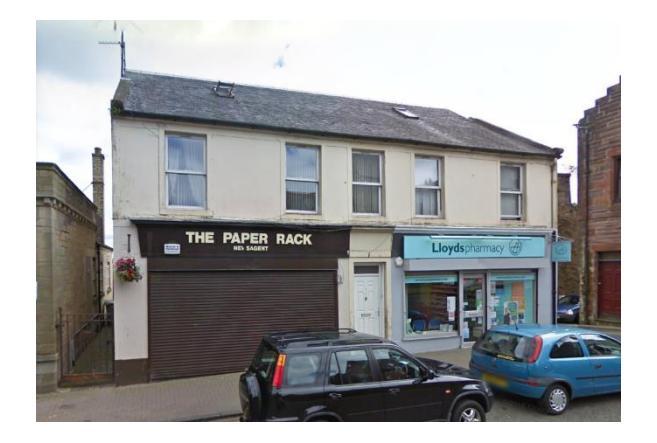
Commercial accommodation on the ground floor with two floors of residential accommodation above.

Potential works:			
Paint façade			
Roof repairs			
Gutters & rainwater goods			
Stonework/chimney repairs			
Window replacement			
Shopfront improvements			
Internal shop works
