Maybole's Regeneration

[']MAYBOLE HERITAGE LOTTERY FUND APPLICATION STAGE 1

TOWNSCAPE & BUILDINGS

AUGUST 2016

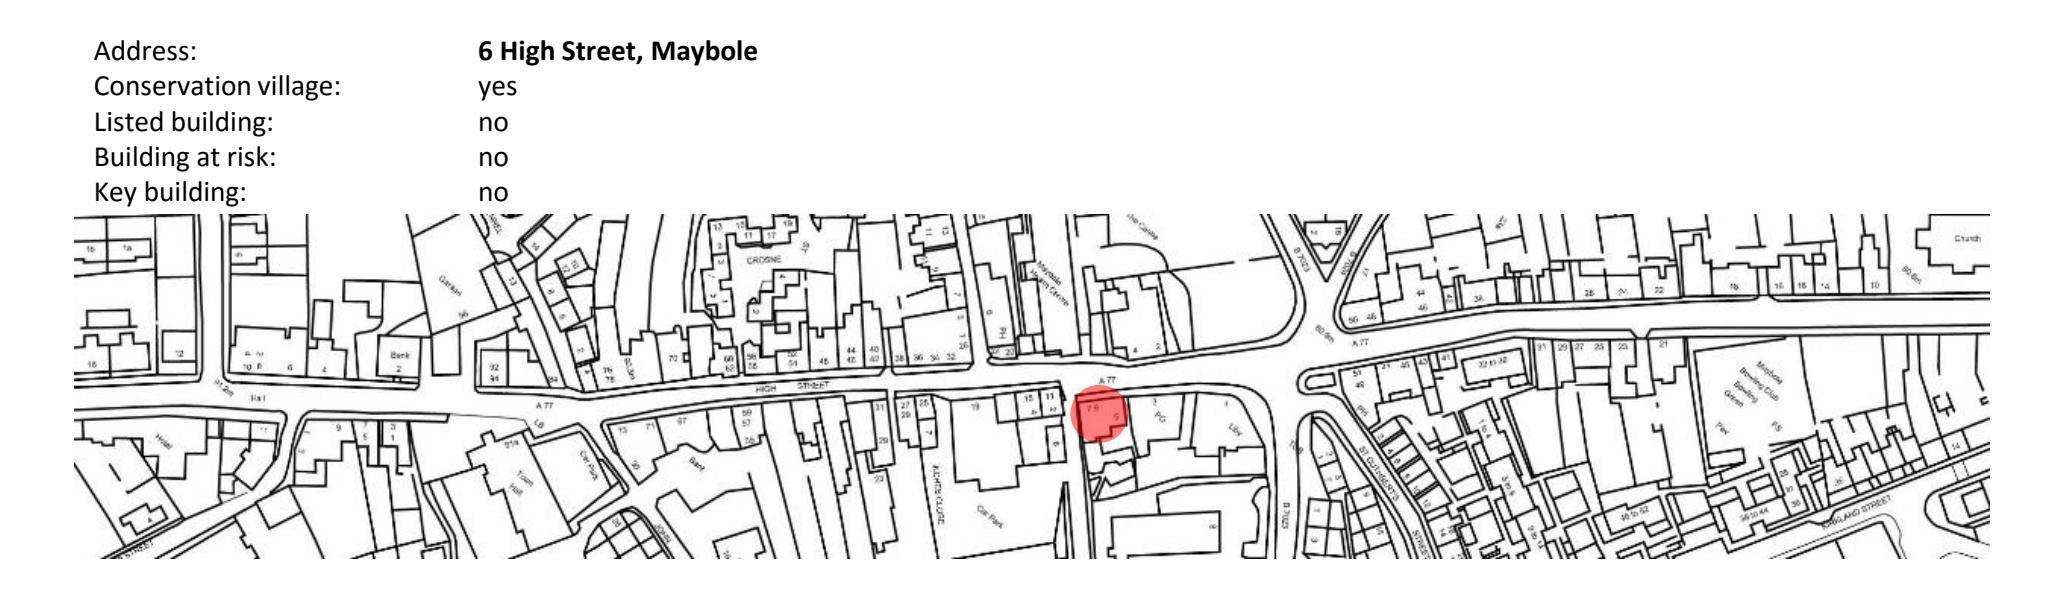
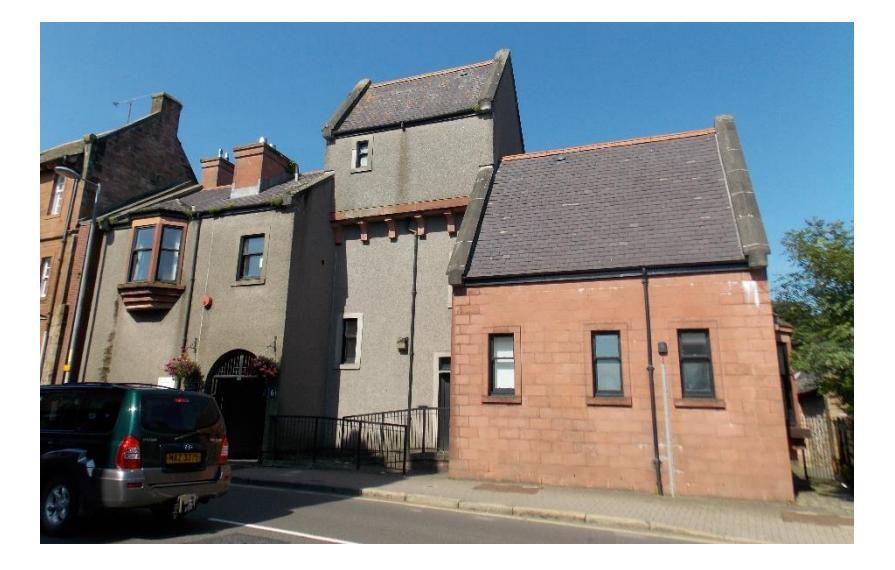
Commercial accommodation on the ground floor with two floors of residential accommodation above. One of the commercial properties is vacant.

Potential works: Paint façade Roof repairs Gutters & rainwater goods Stonework/chimney repairs Window replacement Shopfront improvements Internal shop works

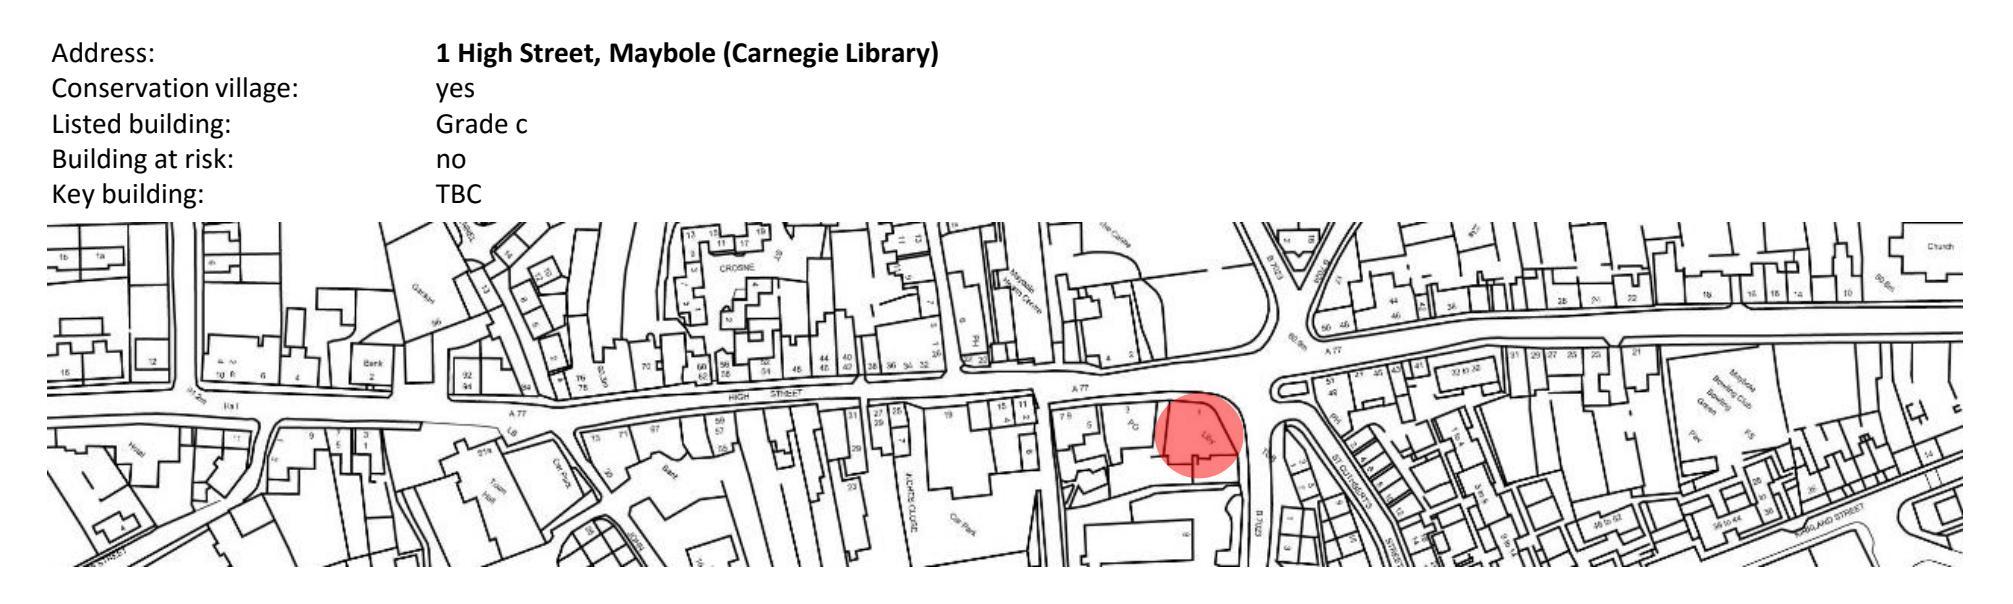
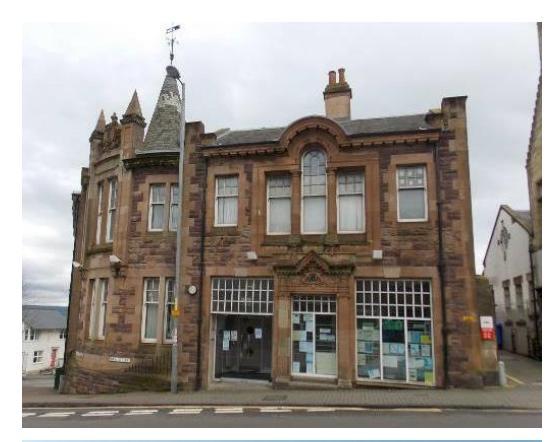
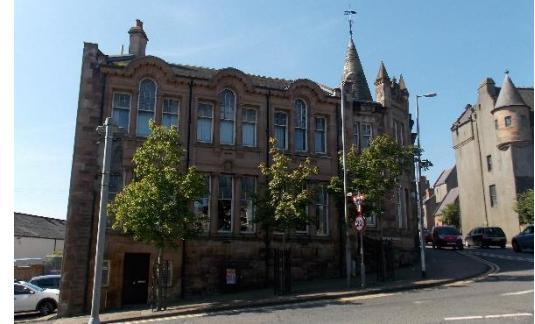
Carnegie Library Building with accommodation over two floors. The library is location on the ground

floor with office space and flexible bookable rooms location on the first floor

Potential works:

Paint façade Roof repairs Gutters & rainwater goods Stonework/chimney repairs Window replacement Shopfront improvements Internal shop works

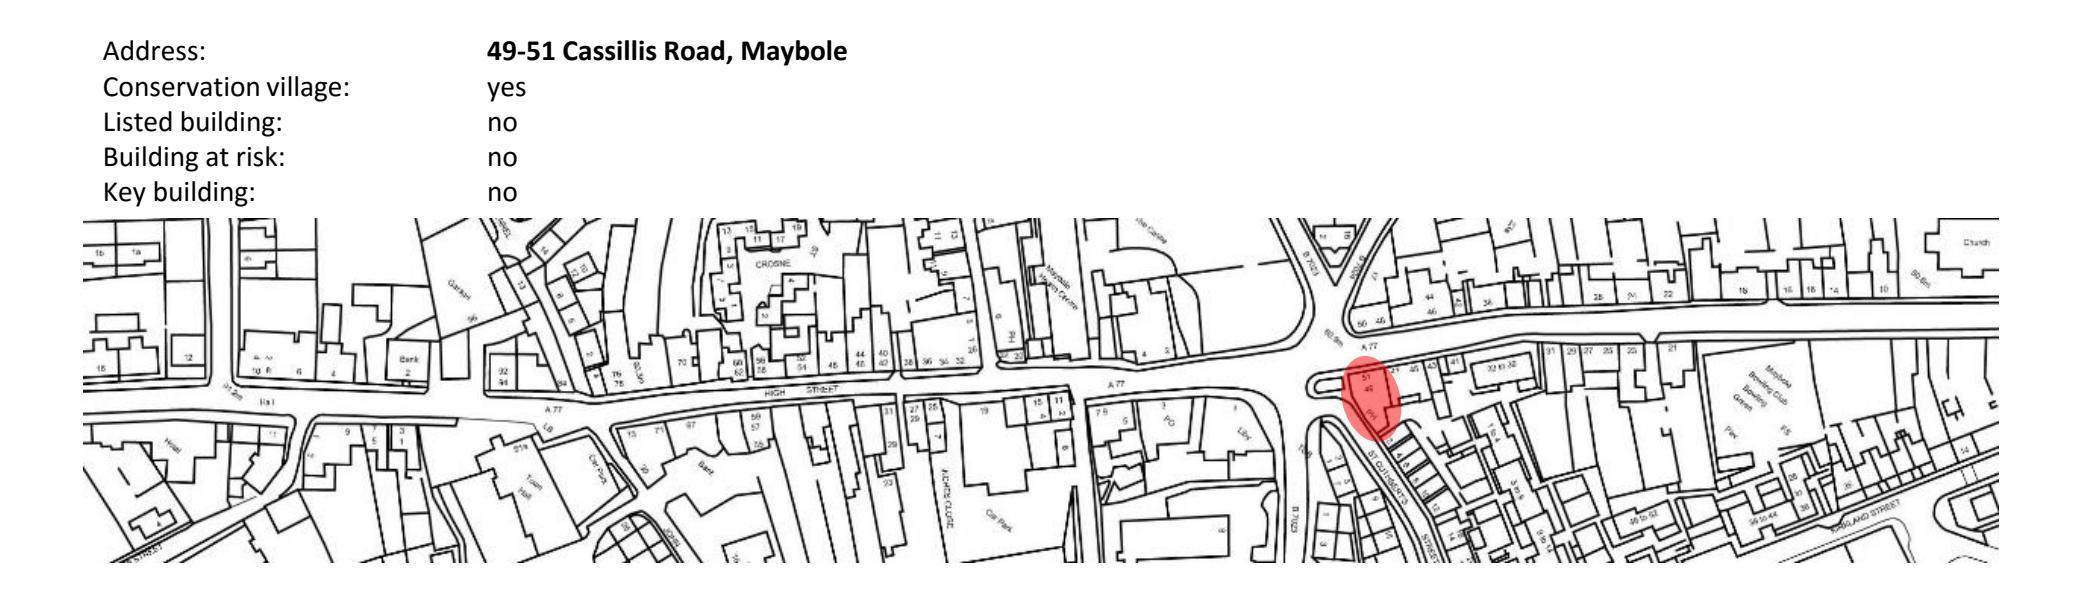
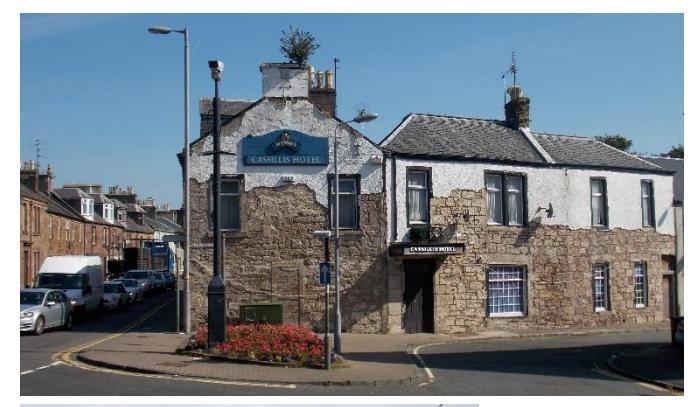
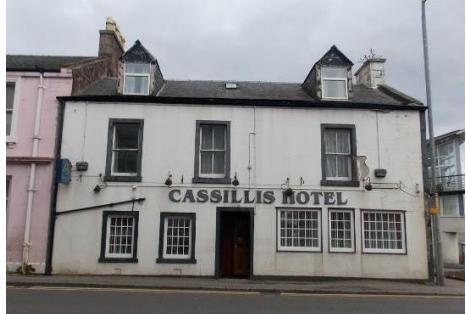
Ground floor traditional pub with accommodate above - at the time of writing the report works were being carried out to the property.

Potential works:

Paint façade Roof repairs Gutters & rainwater goods Stonework/chimney repairs Window replacement Shopfront improvements Internal shop works

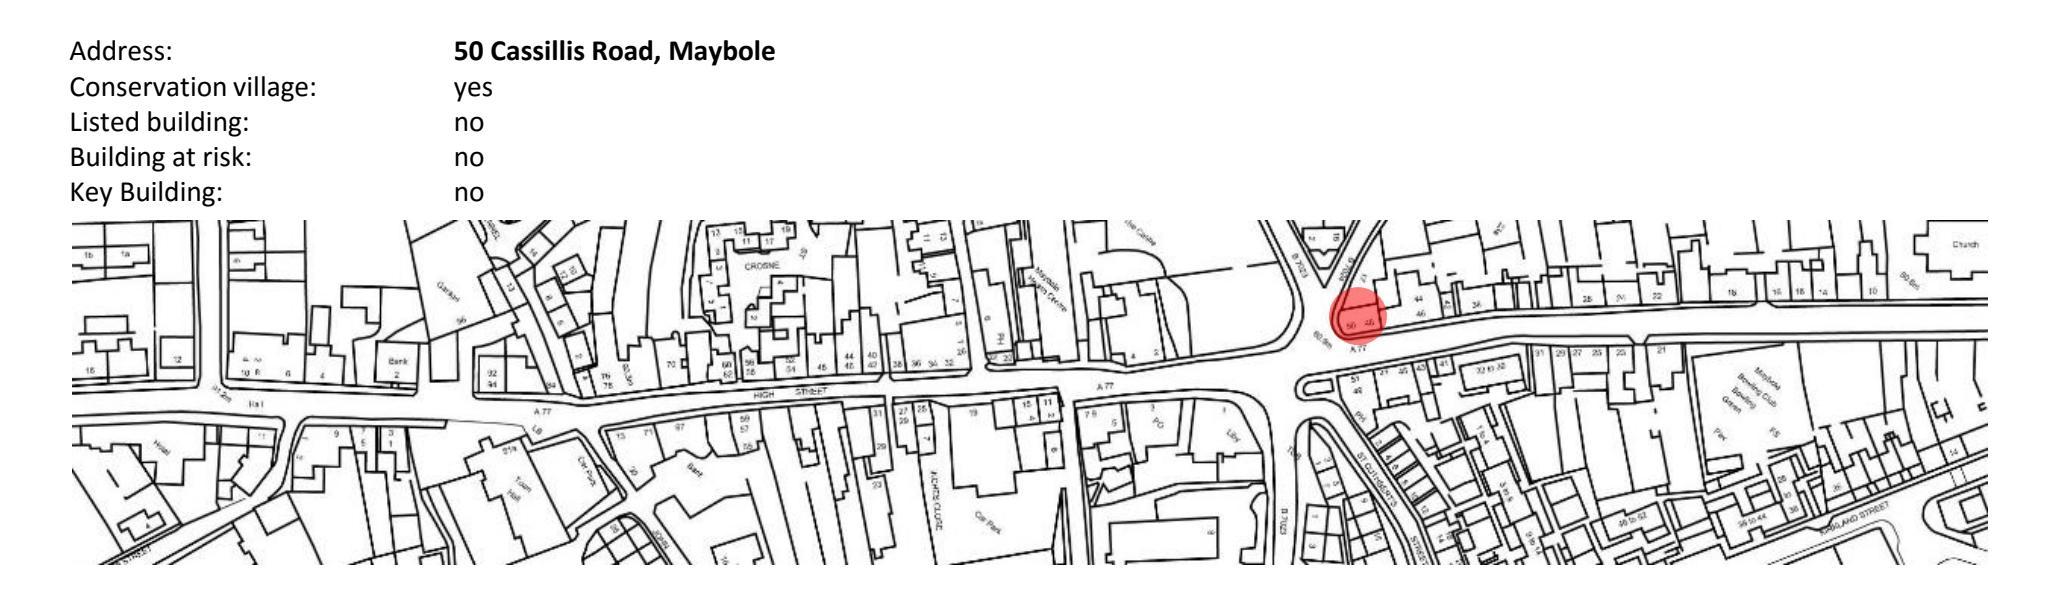
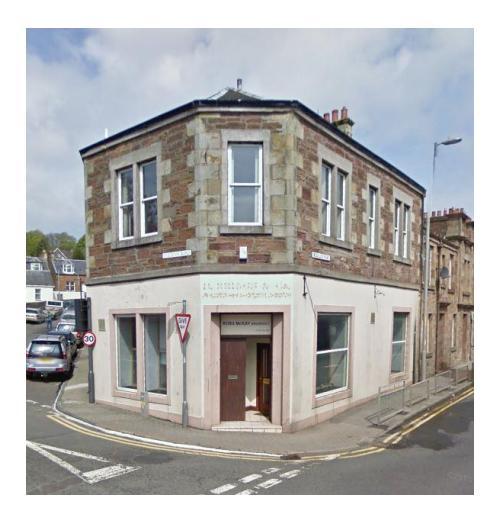
Commercial property on the ground floor with residential accommodation above

Potential works:			
Paint façade			
Roof repairs			
Gutters & rainwater goods			
Stonework/chimney repairs			
Window replacement			
Shopfront improvements			
Internal shop works

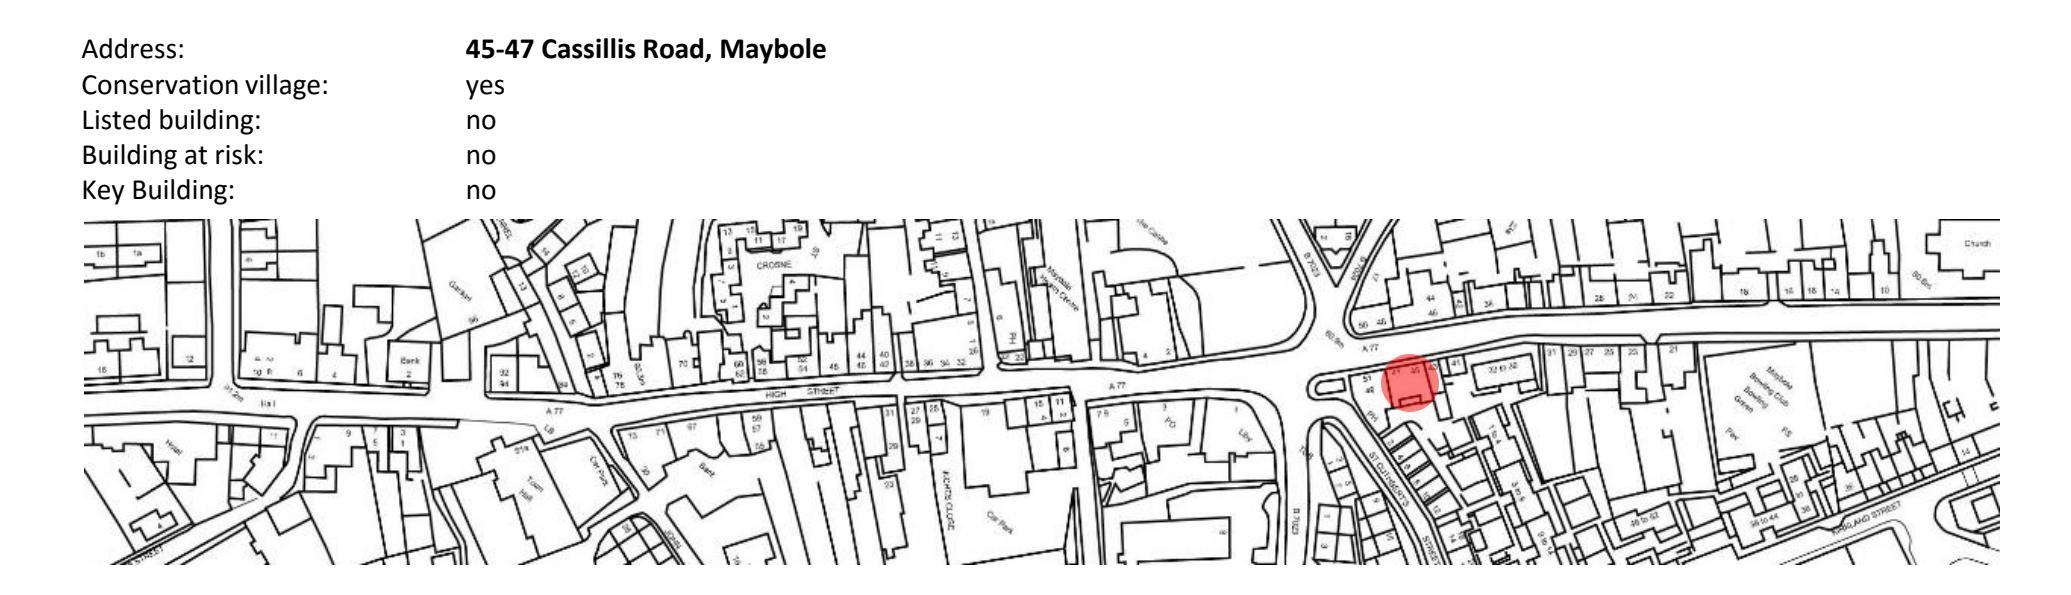
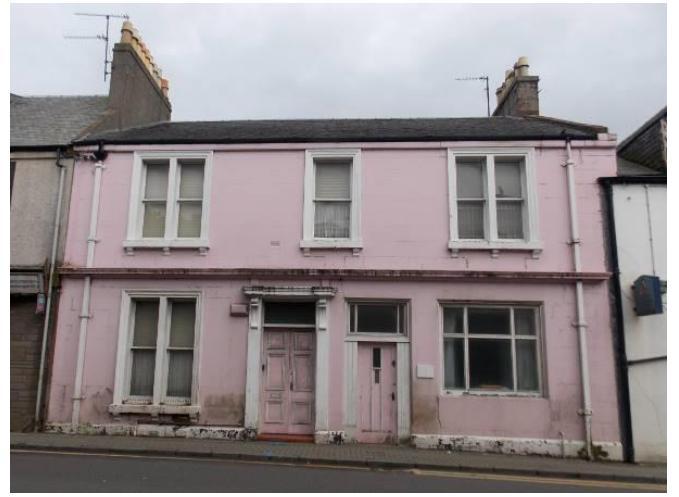
Private residence with accommodation over 2 floors, a GF shop front has been converted at some point

Potential works: Paint façade Roof repairs Gutters & rainwater goods Stonework/chimney repairs Window replacement Shopfront improvements Internal shop works

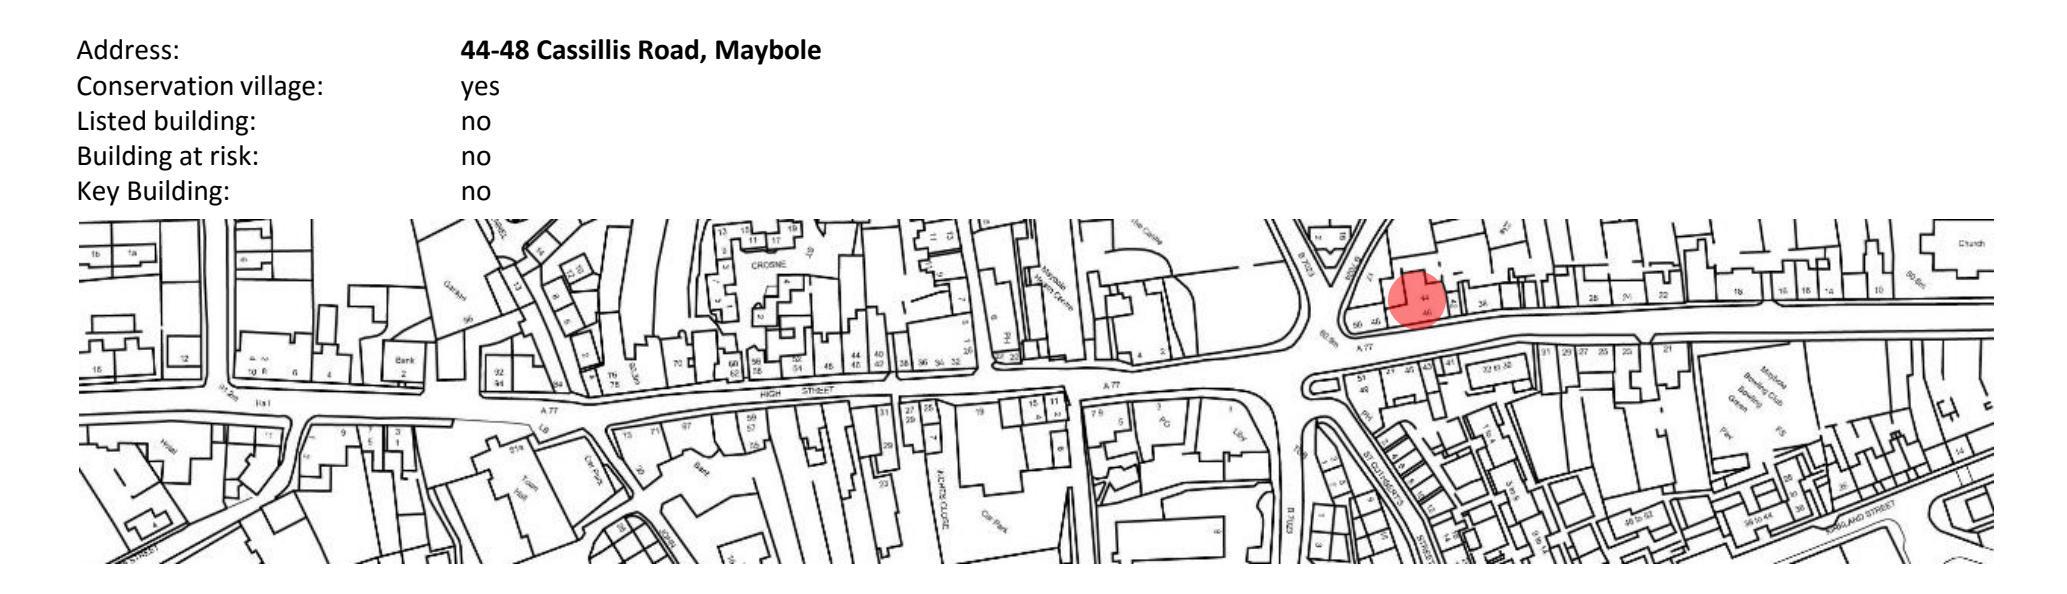
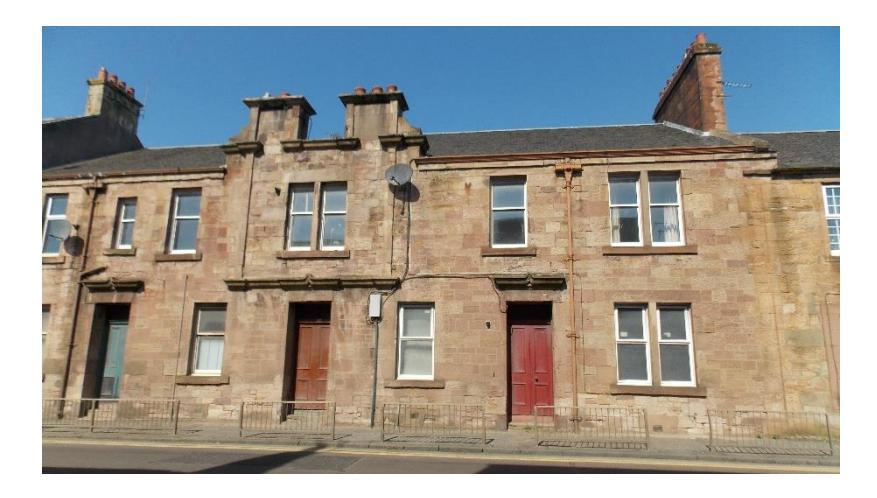
Private residence with accommodation over 2 floors, a GF shop front has been converted at some point

Potential works:

Paint façade Roof repairs Gutters & rainwater goods Stonework/chimney repairs Window replacement Shopfront improvements Internal shop works

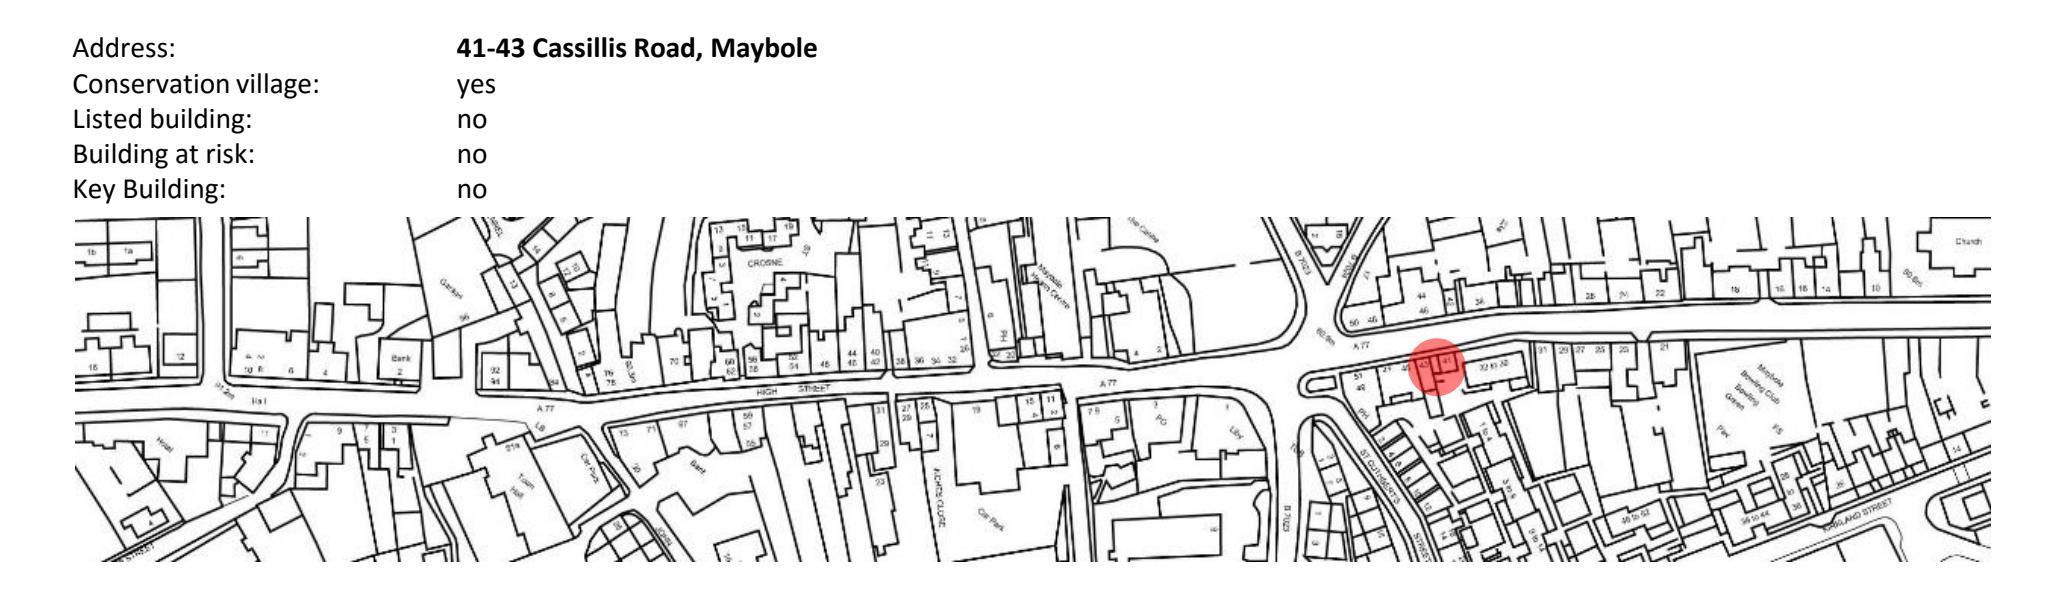
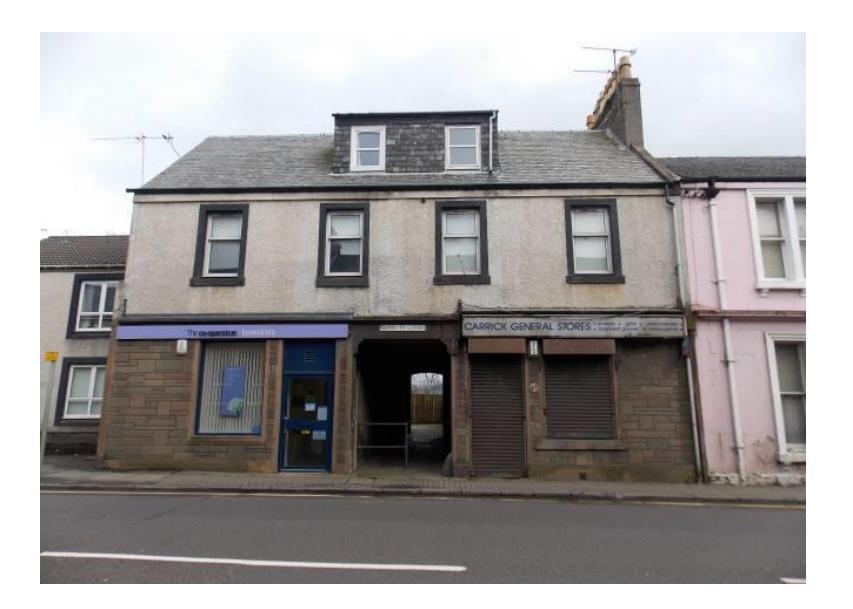
Ground floor commercial properties with two floors of residential accommodation located above. One of the commercial properties is vacant.

Potential works:

Paint façade Roof repairs Gutters & rainwater goods Stonework/chimney repairs Window replacement Shopfront improvements Internal shop works (no. 43)

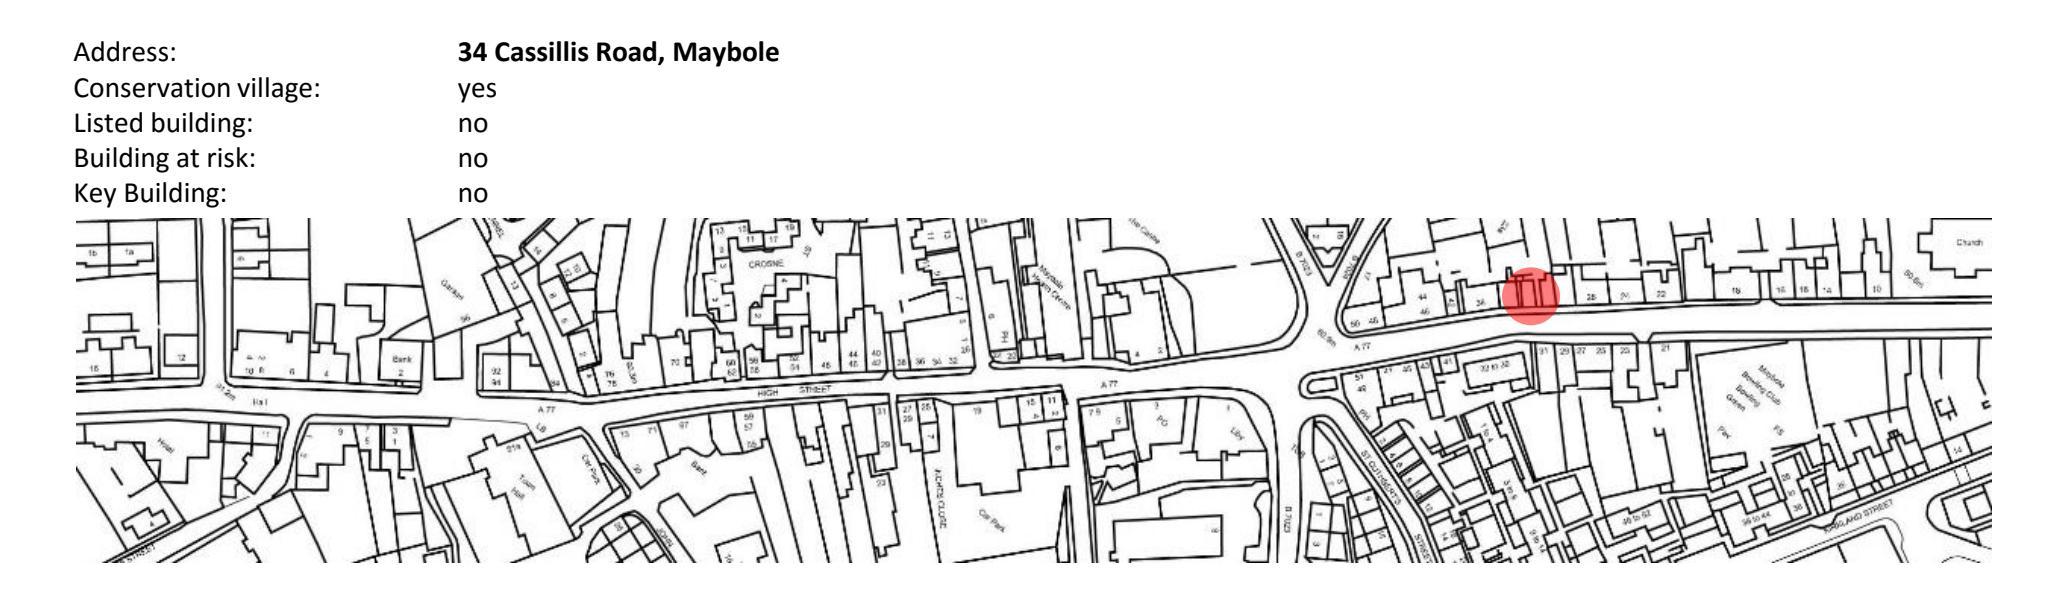
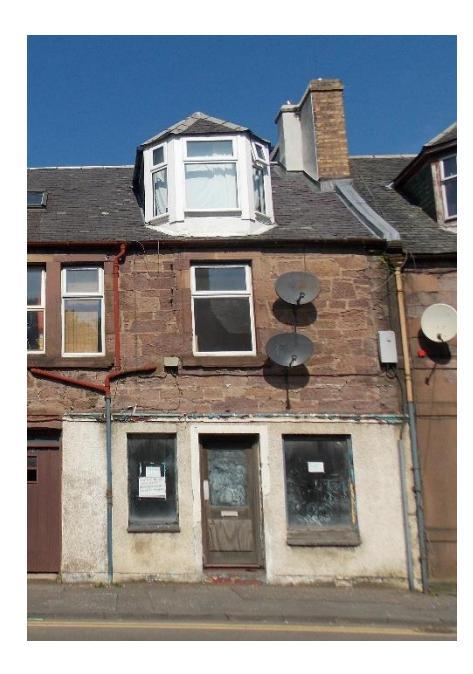
Vacant ground floor commercial property with two floors of residential accommodation located above

Potential works:

Paint façade Roof repairs Gutters & rainwater goods Stonework/chimney repairs Window replacement Shopfront improvements Internal shop works (no 34)

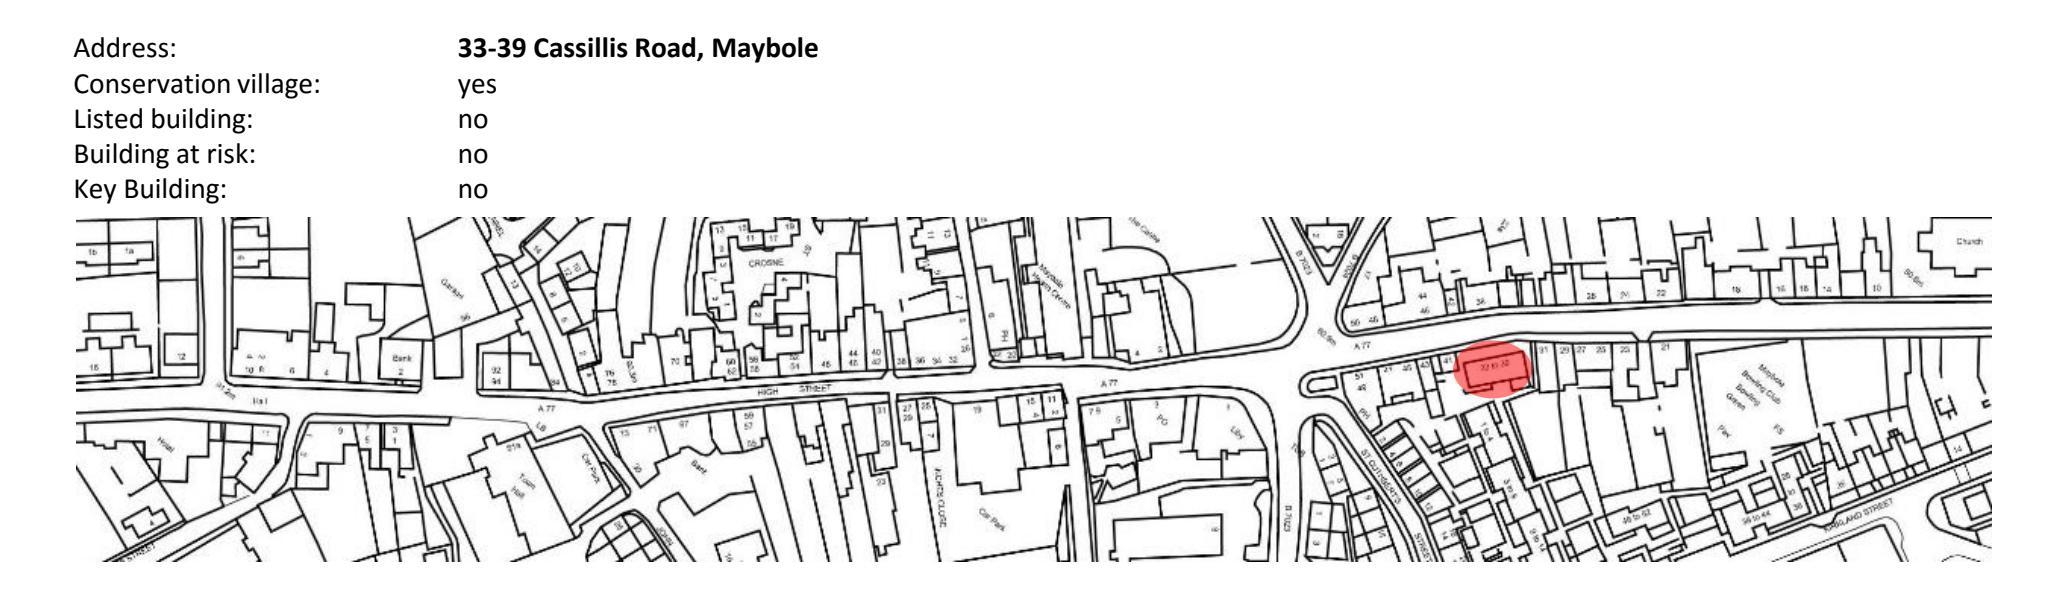
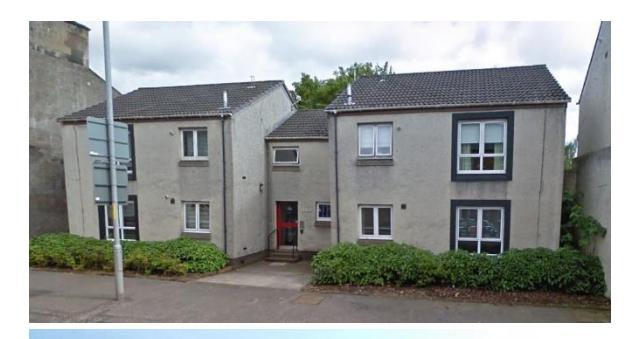
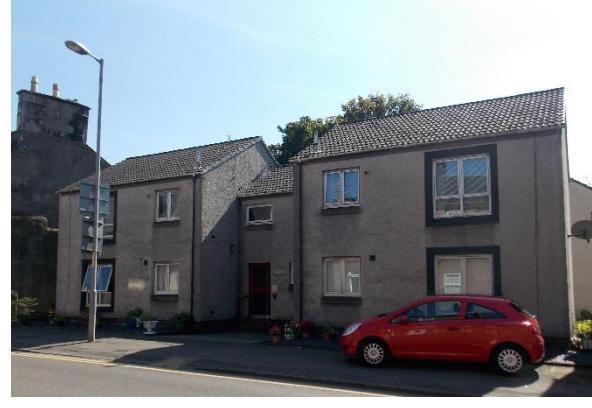
Residential accommodation over two floors, modern construction with harled finish

Potential works:

Paint façade		
Roof repairs		
Gutters & rainwater goods		
Stonework/chimney repairs		
Window replacement		
Shopfront improvements		
Internal shop works

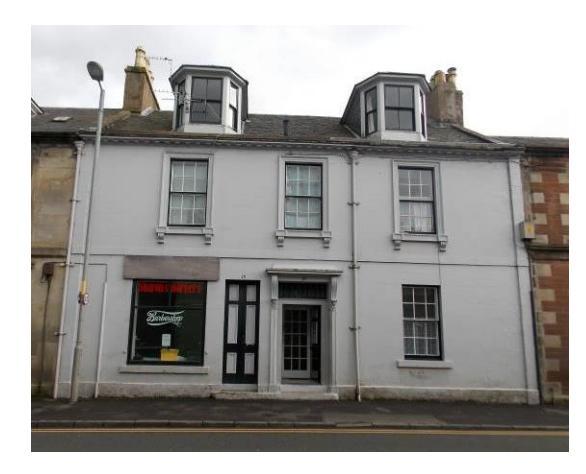
Single ground floor commercial property with two floors of residential accommodation located above and three floors of residential accommodation to the other side of the building. The commercial property is currently vacant.

Paint façade	
Roof repairs	
Gutters & rainwater goods	
Facia repairs	
Stonework/chimney repairs	
Window replacement	
Shopfront improvements	
Internal shop works (no 25)

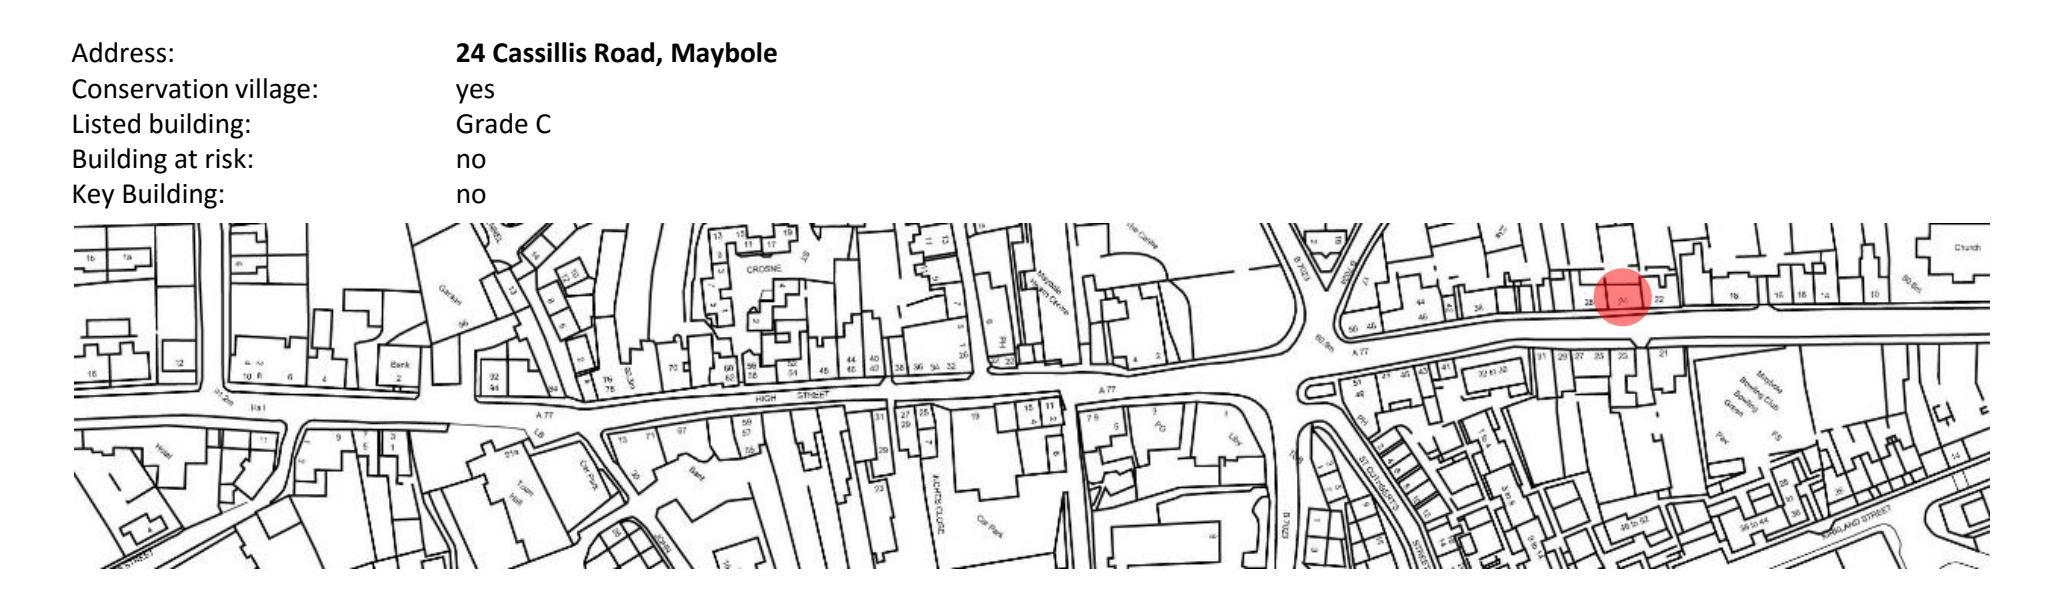
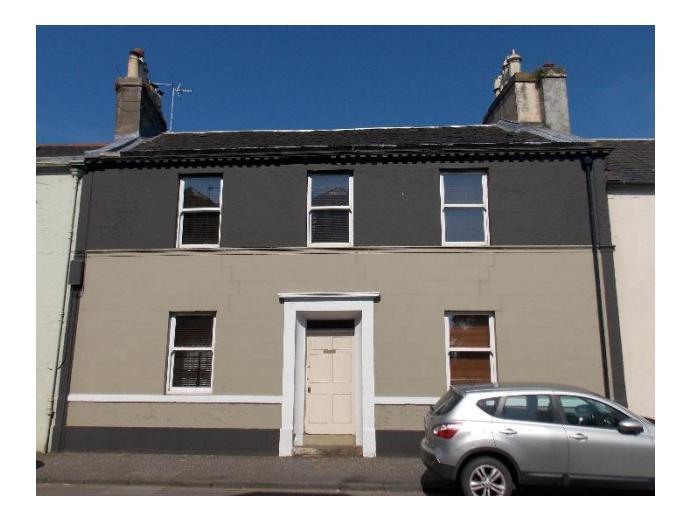
Private residential property with accommodation over two floors

Paint façade Roof repairs Gutters & rainwater goods Facia repairs Stonework/chimney repairs Window replacement Shopfront improvements Internal shop works

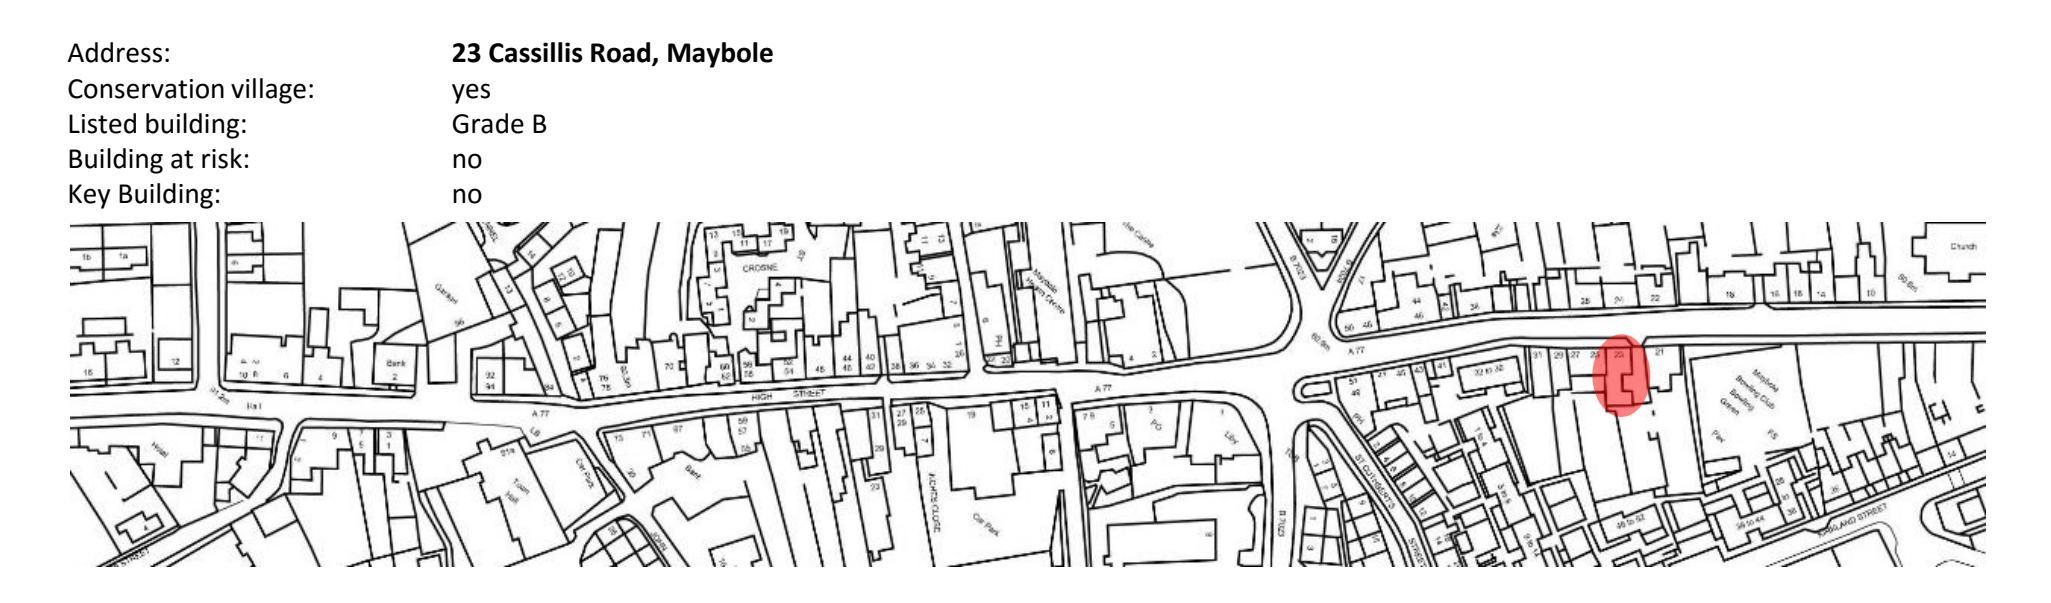
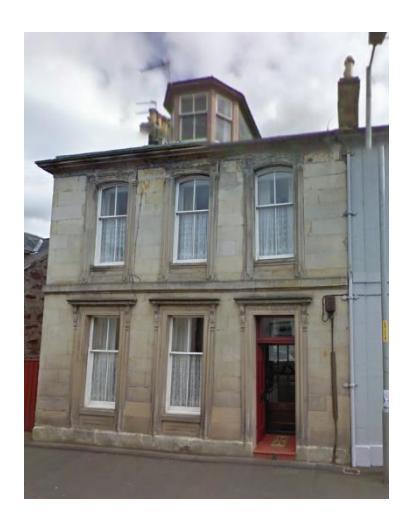
Private residential property with accommodation over three floors

Paint façade	
Roof repairs	
Gutters & rainwater goods	
Facia repairs	
Stonework/chimney repairs	
Window replacement	
Shopfront improvements	
Internal shop works

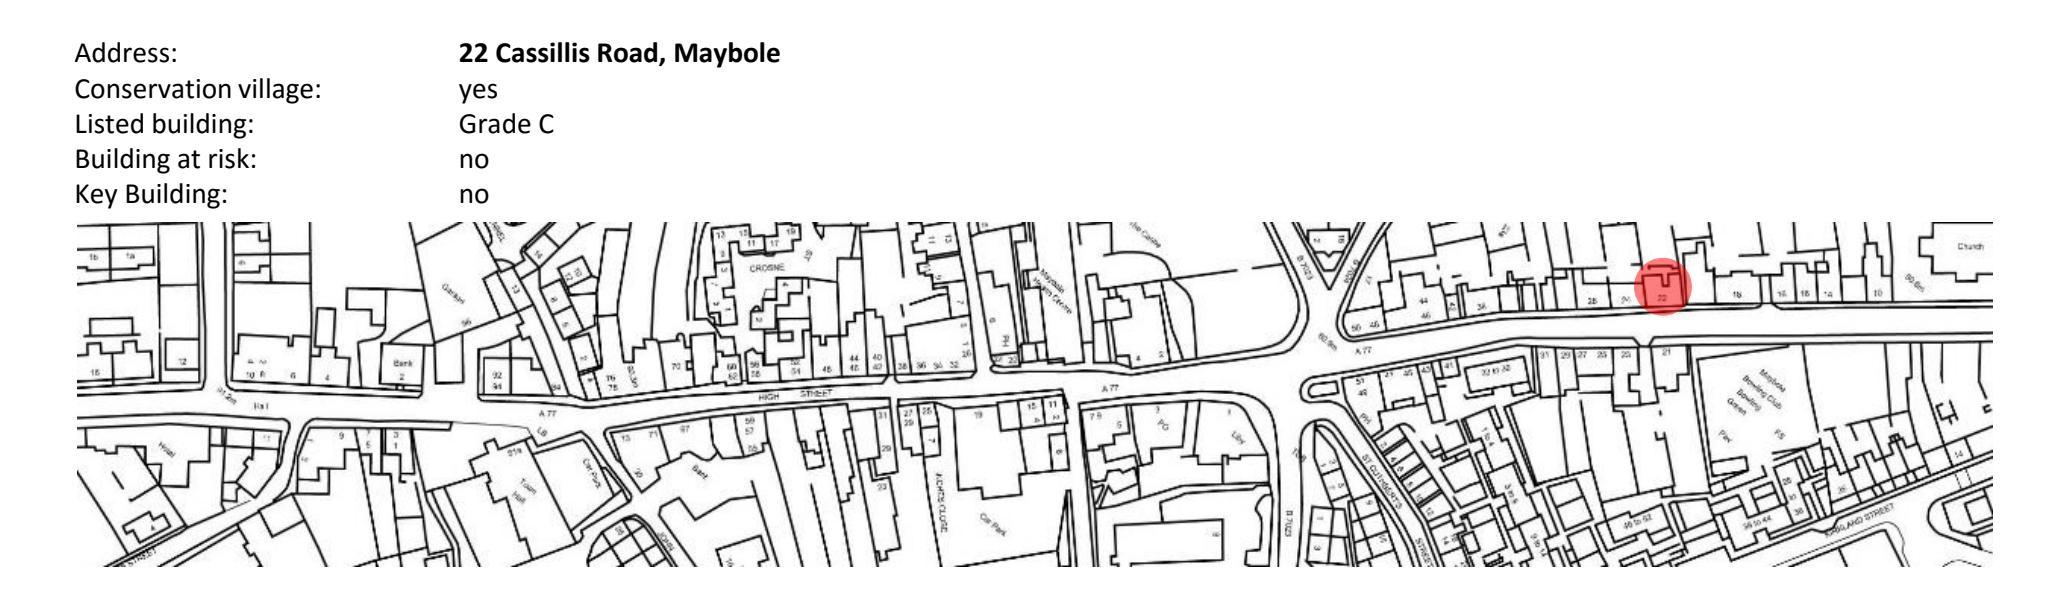
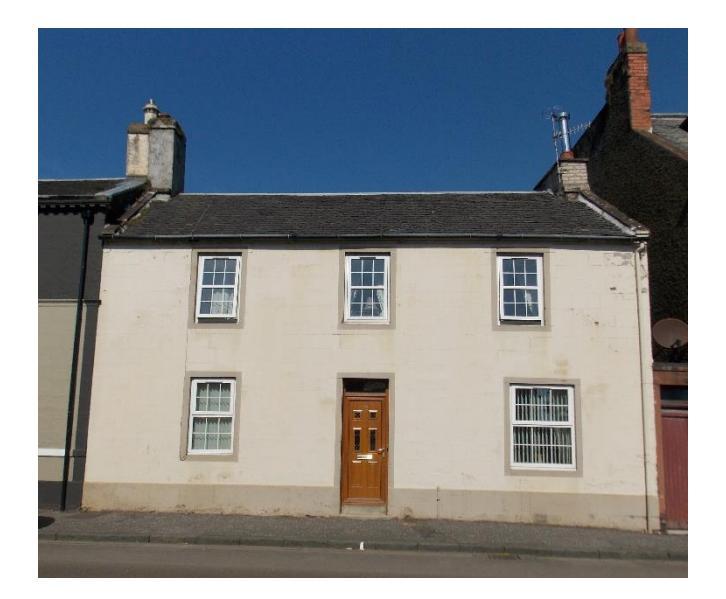
Private residential property with accommodation over three floors

Potential works: Paint façade Roof repairs Gutters & rainwater goods Stonework/chimney repairs Window replacement Shopfront improvements Internal shop works

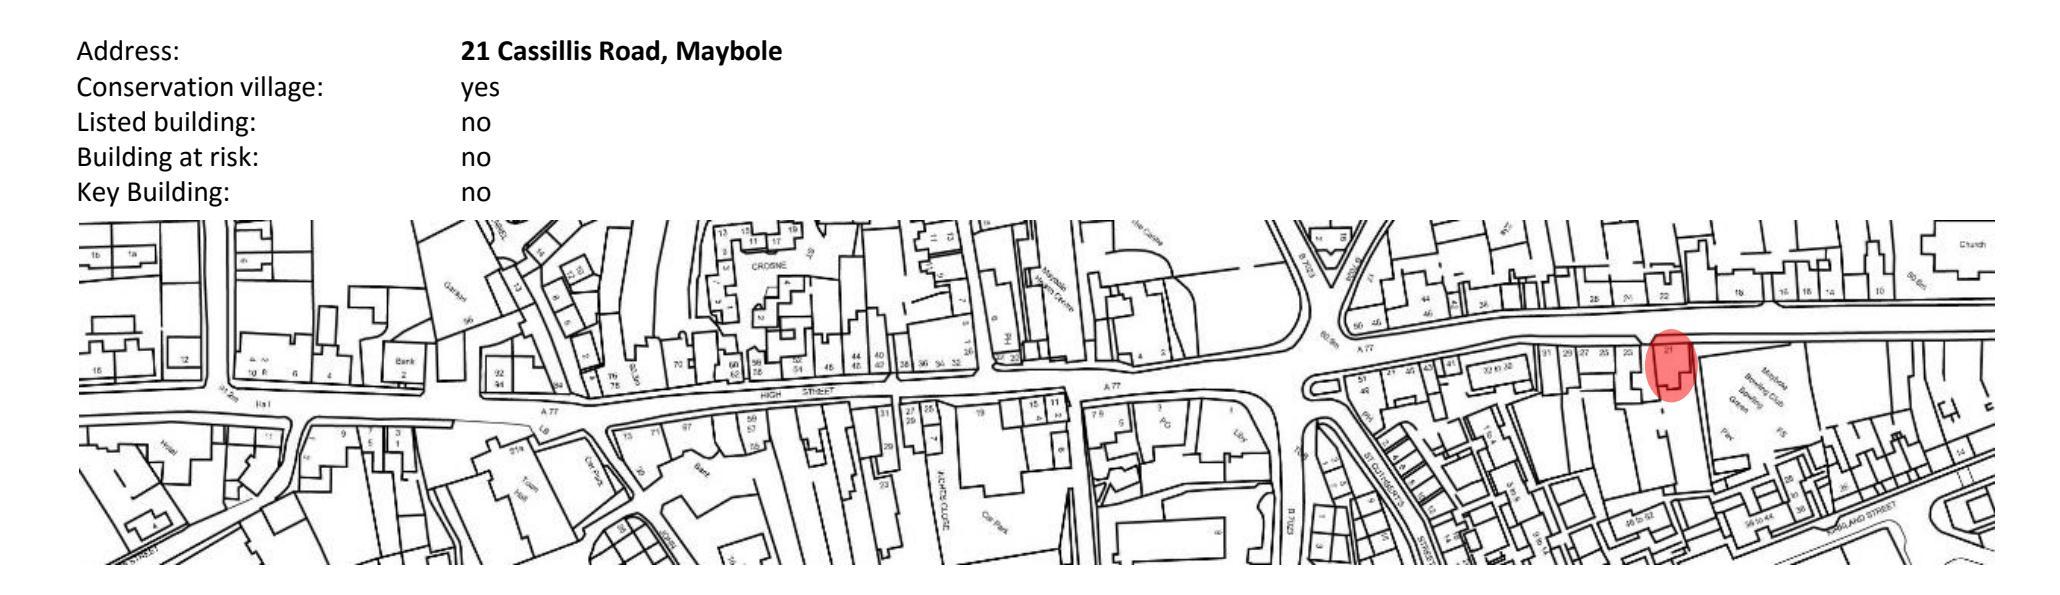
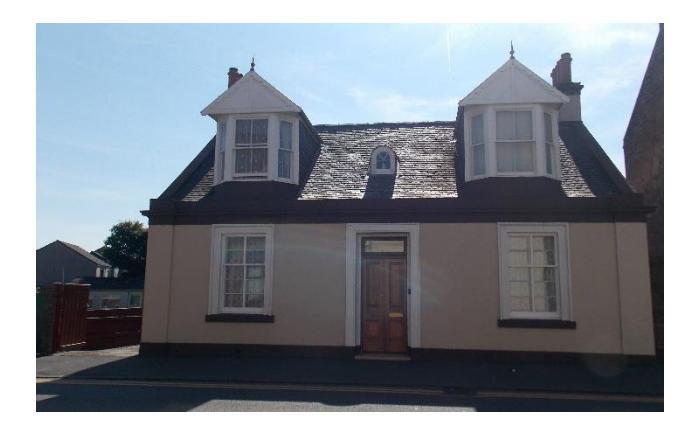
Private residential property over 2 floors

Potential works: Paint façade Roof repairs Gutters & rainwater goods Stonework/chimney repairs Window replacement Shopfront improvements Internal shop works
