Maybole's Regeneration

[']MAYBOLE HERITAGE LOTTERY FUND APPLICATION STAGE 1

TOWNSCAPE & BUILDINGS

AUGUST 2016

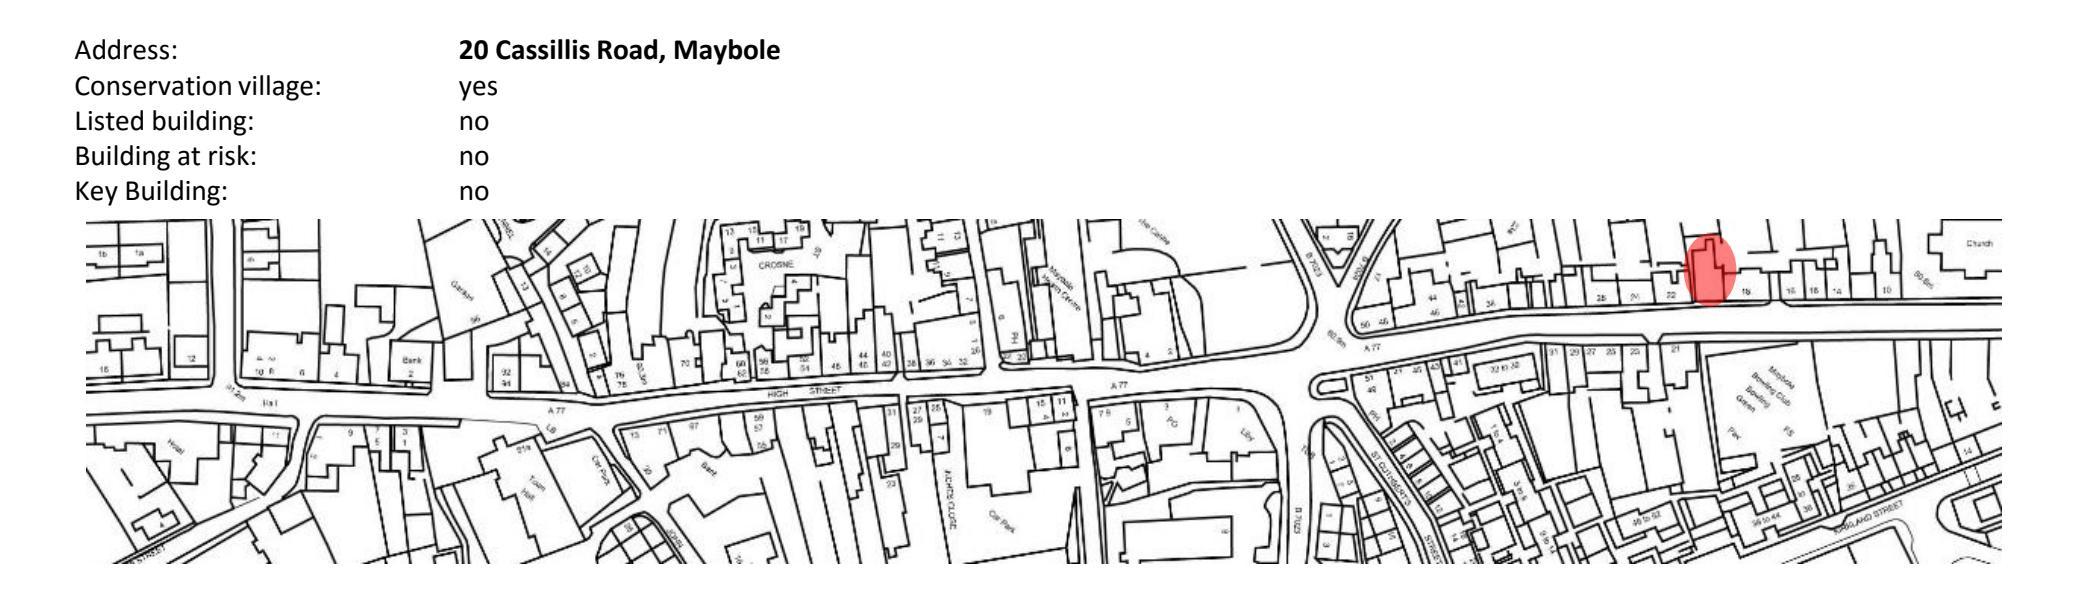
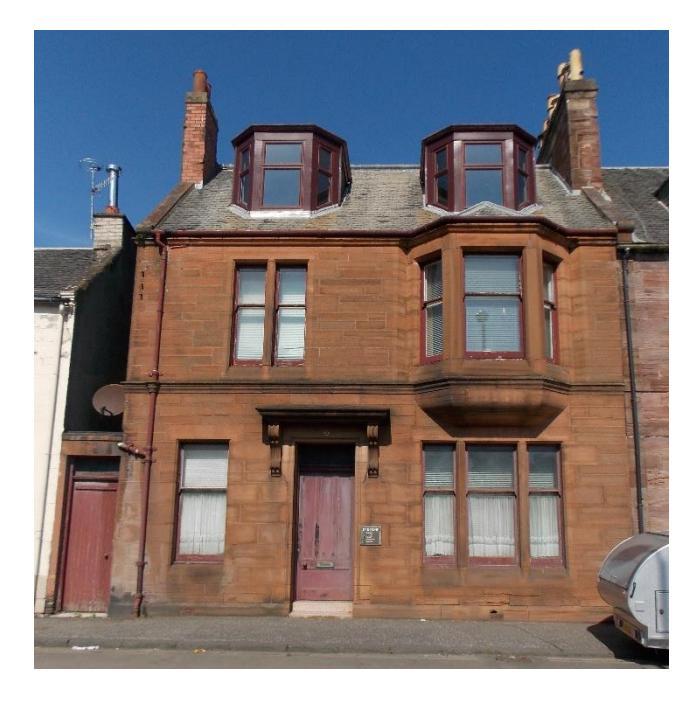
Private residential property with accommodation over three floors

Paint façade		
Roof repairs		
Gutters & rainwater goods		
Stonework/chimney repairs		
Window replacement		
Shopfront improvements		
Internal shop works

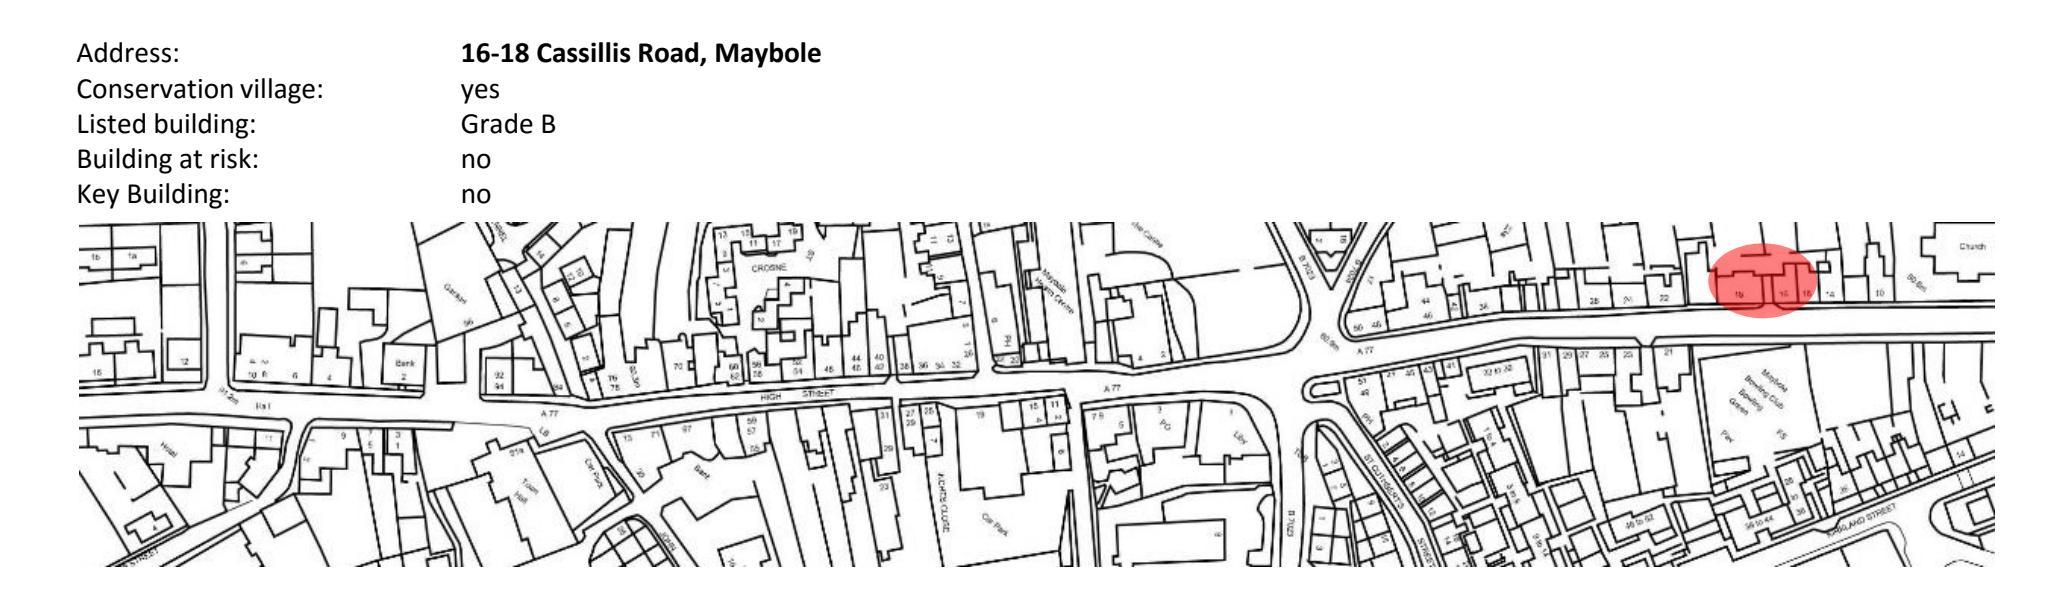
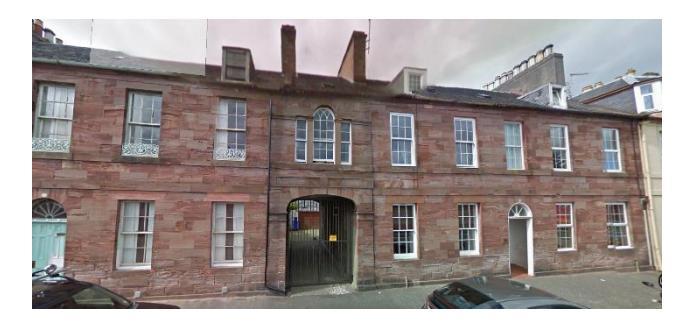
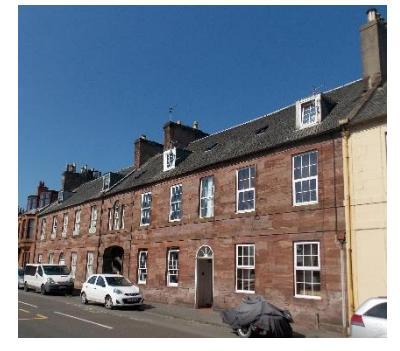
Private residential properties with accommodation over three floors and access to rear courtyard and mews building

Paint façade Roof repairs Gutters & rainwater goods Stonework/chimney repairs Window replacement Shopfront improvements Internal shop works

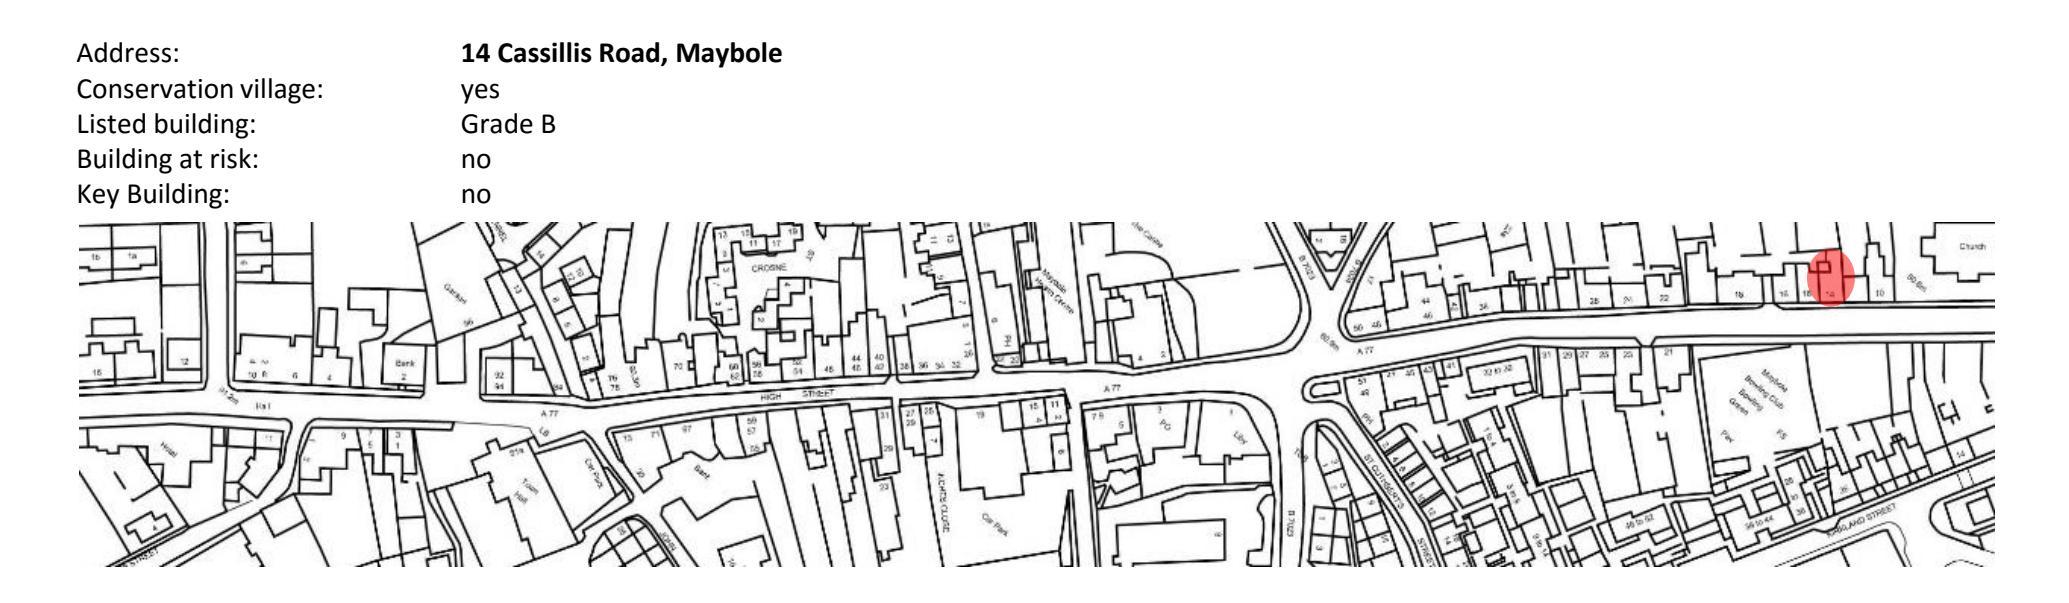
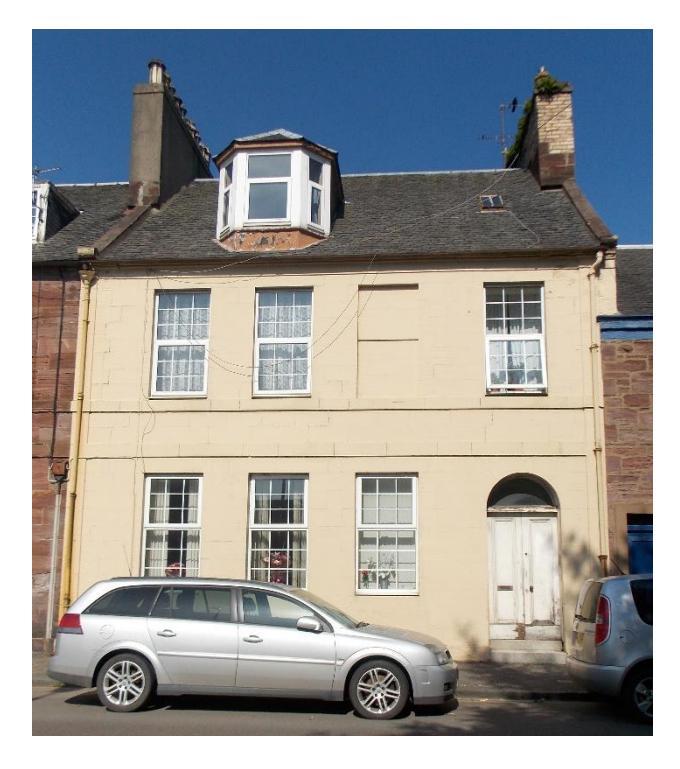
Private residential property with accommodation over three floors

Potential works: Paint façade Roof repairs Gutters & rainwater goods Stonework/chimney repairs Window replacement Shopfront improvements Internal shop works

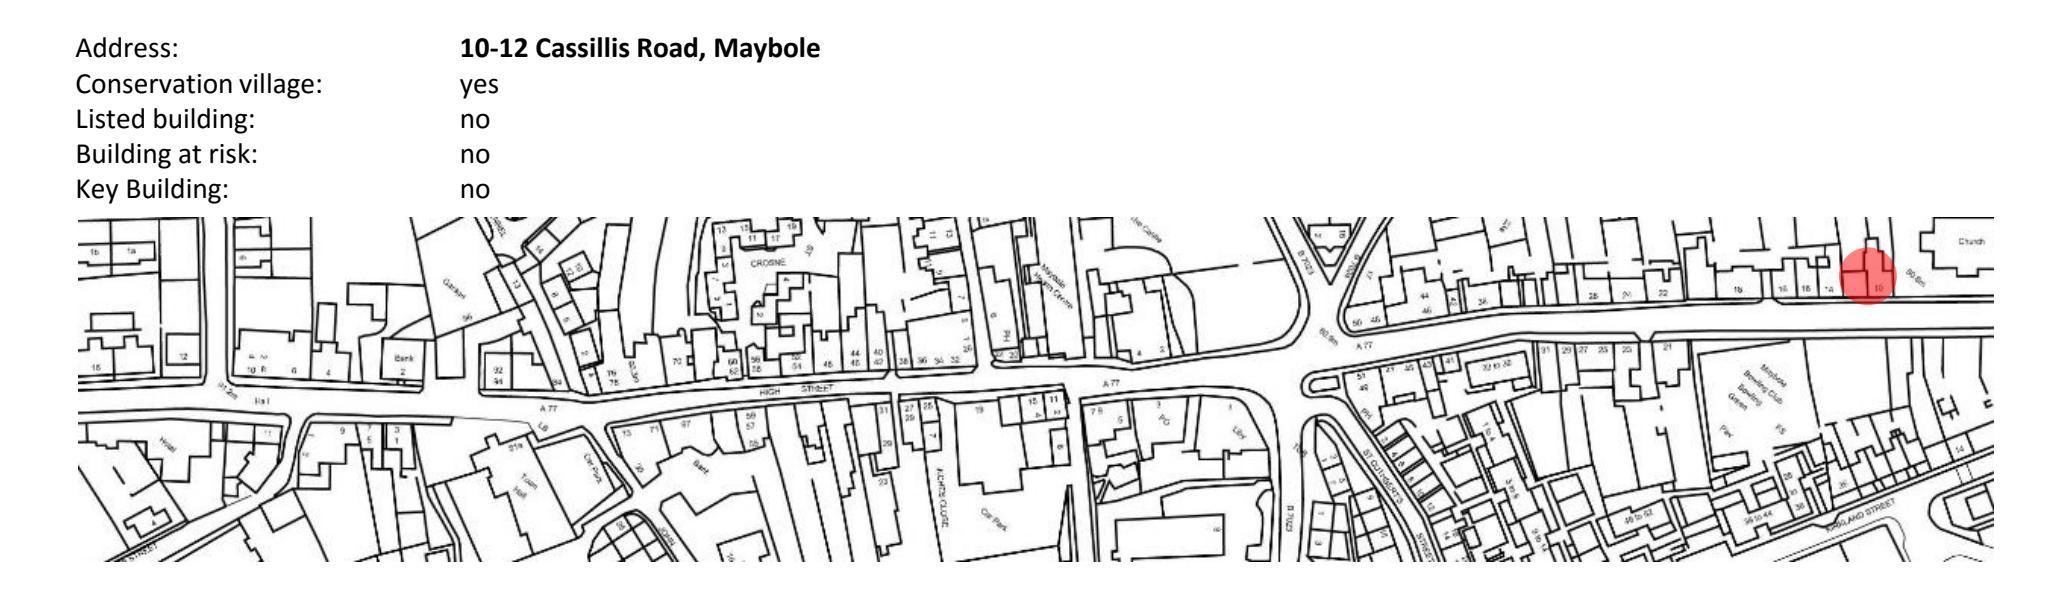
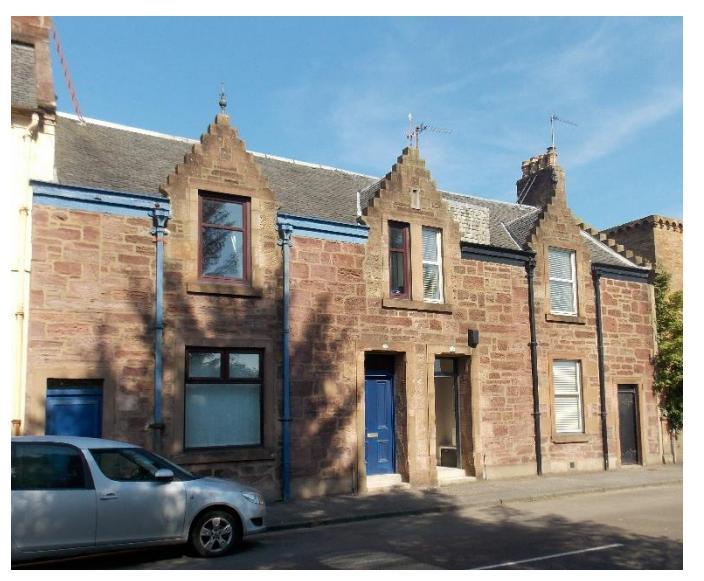
Private residential properties with accommodation over two floors

Paint façade Roof repairs Gutters & rainwater goods Stonework/chimney repairs Window replacement Shopfront improvements Internal shop works

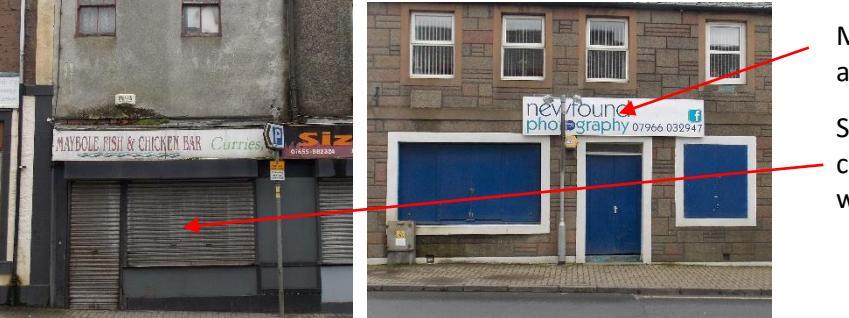
Mixture of signage arrangements

Security shutters create a visual barrier when closed

- 1. Façade Cleaning: post bypass
- 2. General shop front repairs
- 3. Paint decoration
- 4. Reinstatement/ enhancement of traditional features
- 5. Traditional shop front windows where appropriate
- 6. Replacement security grills alternative to roller shutters where appropriate
- 7. Replacement signage

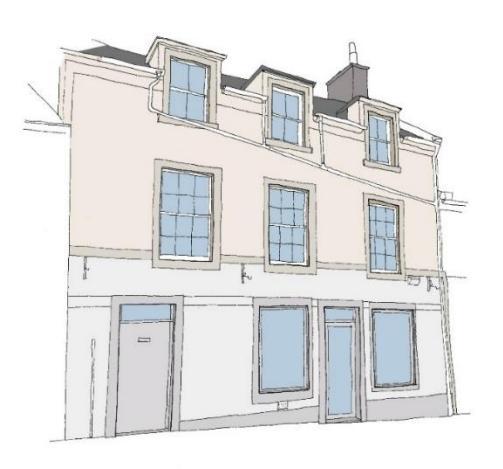
No. 48- 50 (not listed, but on at risk register)

The building whilst vacant seems to be in relatively sound condition comprising of a larger ground floor shop premises with large garden to the rear and two floors of accommodation above. The upper accommodation is accessed directly from the high street via a main door. The building is located centrally within the high street

The proposal is to provide financial assistance to make the building wind & watertight where required, refurbish the shop front, modernise internally with new electrics, heating & repair internal surfaces to make it an attractive proposition for a business on the ground floor and accommodation above Alternative uses for the ground floor shop such a: healthcare base (treatment room etc.) office space/local authority base etc. should be also be considered in the short to medium term should there be low demand for retail units. There is a potential for the rear garden space to be linked in some manner and utilised in part by the retail unit.

- Minor repairs to slate roof, chimney, copes, leadwork gutters & rainwater goods ٠ to ensure in sound condition
- Clean and paint façade ٠
- Refurbish existing traditional windows .
- Replacement shop front windows and external doors .
- New shop front signage
- General internal modernisation throughout building: wiring heating plumbing etc..
